Troubleshooting tree for Vario roof R230

Noise, leakage, fit and function analyses and the most important repair jobs including the associated damage codes and chassis numbers (VIN)

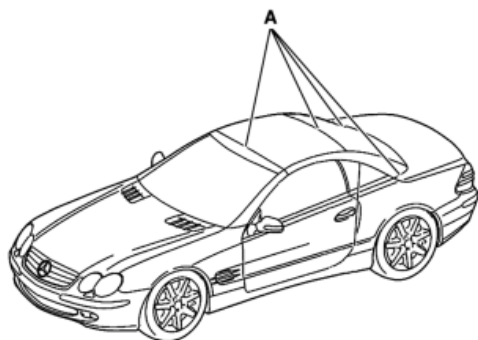
1.2.1 At the seals

Complaint: Tearing/rubbing noises at all the seals on the Vario roof.

Cause: Dry, dirty seals on the Vario roof are the most common cause of cracking and tearing noises while driving.

Action: Treat seals (A) on Vario roof with special antifriction agent, part no. A 000 989 50 51 or A 001 989 36 60, see AF77.30-P-1501AG.

Note: Observe proper application (penetration time 20 min) of the special antifriction agent.

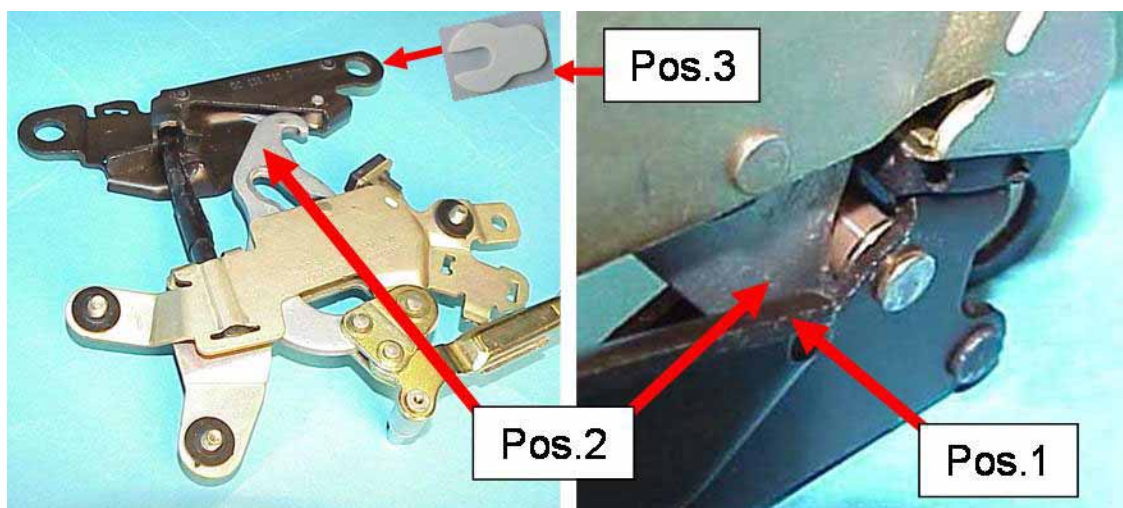
1.2.2 Area of front latch socket

Complaint: Hard tearing noise (cracking) from the area of the front Vario roof socket/latch while driving.

Cause: Base of socket (item 1) for latch hook (item 2) too high, latch hook (item 2) touches the base (item 1) in the socket.

Action: Adjust the socket (item 1) so that the latch hook (item 2) is in the center of the latch (item 1) and does not come into contact with the base when the Vario roof is locked, see AF77.30-P-1560AG.

Note: The installation position and part no. of the shims (item 3) have been changed. Install shims (item 3) in the direction of the arrow.

New part no. of shims: A 230 795 14 96

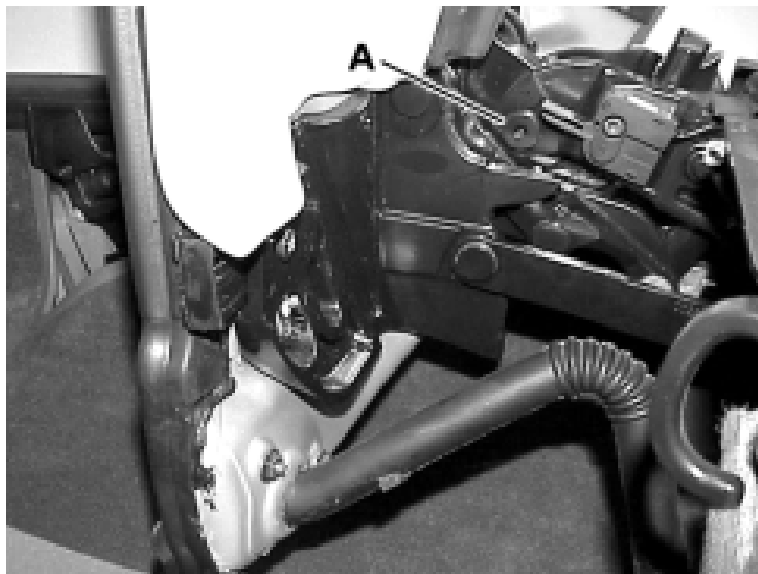
1.2.3 Area of C-pillar pivot point

Complaint: Rattling noises or knocking in the area of the C-pillar pivot point.

Cause: Play at the bolt (A) in the C-pillar pivot point.

Action: Replace bolt (A), part no. A 007 990 09 04, in intermediate bearing, see AF77.30-P-1502AG.

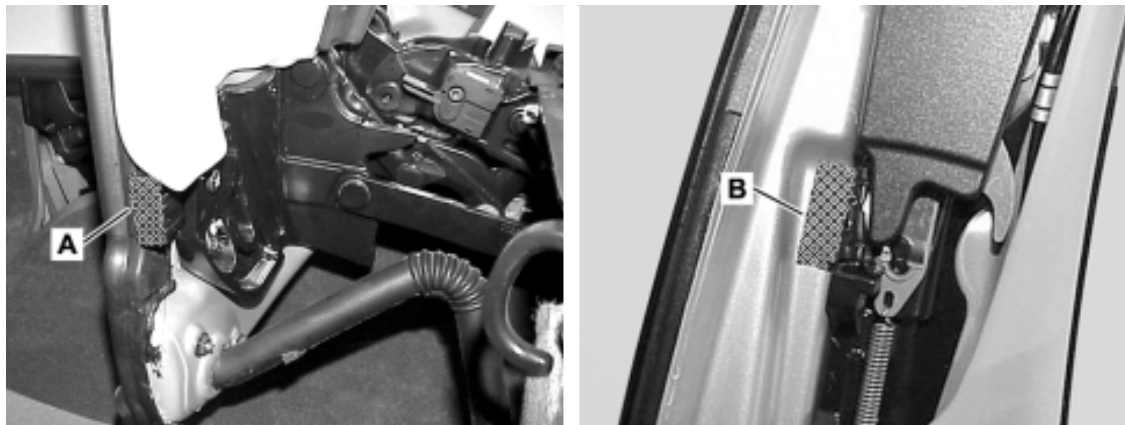
1.2.4 Area of rear window stop on C-pillar

Complaint: Noises in the area of the rear window Y-stops at the bottom of the C-pillar.

Cause: Adjustment of Y-stops not OK (too much play).

Action: Check adjustment of Y-stops (A)/(B) on C-pillar and correct if necessary. Grease Y-stops with lubricant paste, part no. A 001 989 46 51 (hatched area).

Note: The Y-stops (A) at the bottom of the C-pillar are accessible under the Vario roof when the trunk lid is open. Slacken the bolts, slide the stop as far as the thrust bearing of the rear window and retighten the bolts.

The Y-stops (B) at the top of the C-pillar are not usually the cause of complaints and can be adjusted, if necessary, with the Vario roof in the upright position.

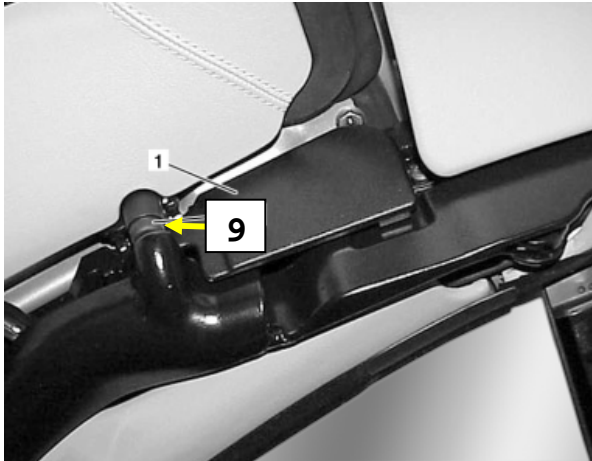
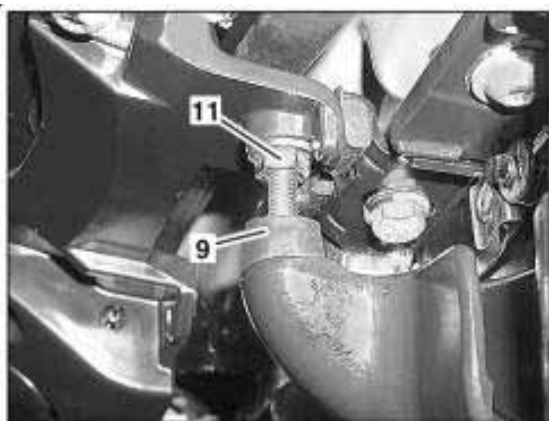
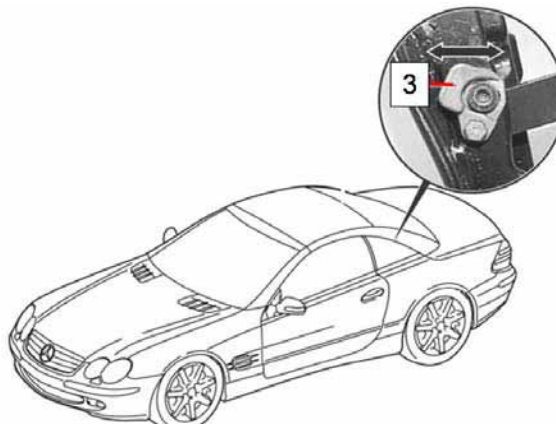
1.2.5 Area of rear window stop buffers

Complaint: Noises in the area of the rear window stop buffer.

Cause: Adjustment of stop buffers (9) not OK.

Action: **Adjust stop buffer:**
Move Vario roof to upright position, remove left and right cover sleeves, slacken lock nut (11), screw in stop buffer (9) and close Vario roof again. Unscrew stop buffer (9) until it touches the roof frame, open Vario roof again, unscrew stop buffer (9) one half turn, tighten lock nut (11), push on cover sleeve. Grease stop buffer (9) with lubricant paste, part no. A 001 989 46 51.

Important: If the setting of the stop buffer (9) is changed, the setting of the cam (3) must then be checked and corrected if necessary. The settings of the stop buffer (9) and of the cam (3) influence each other.

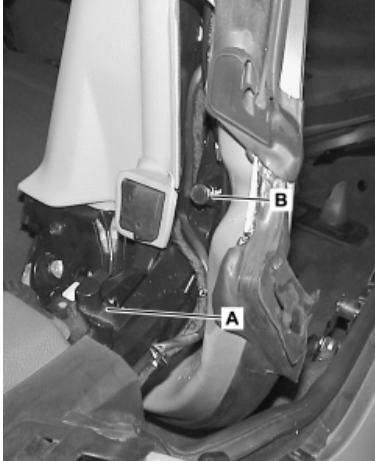
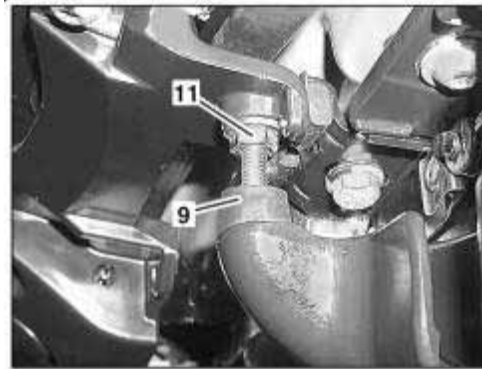
1.2.6 Area between C-pillar guide stop screw and intermediate bearing

Complaint: Cracking noises in the area of the C-pillar guide.

Cause: Unfavorable material pairing between stop screw and intermediate bearing.

Important: If the stop screw is set with excessive bias, the contour of the Vario roof will be negatively affected and this may in certain circumstances result in wind noises and water ingress.

Action: Check contact pressure of stop screw (B) on intermediate bearing (A) using a strip of paper, and adjust if necessary.

Important: If the setting of the stop screw (B) is corrected, you must then carry out the steps 1.2.5 "Adjust stop buffer (9)" and 1.2.7 "Locking cam (3) on C-pillar".

Open Vario roof, slacken lock nut on stop screw, unscrew stop screw one half turn and tighten lock nut. Grease head of stop screw (B) with lubricant paste, part no. A 001 989 46 51.

Note: The stop screw (B) is correctly set if the paper strip cannot be pulled out under moderate pressure when the Vario roof is locked.
Lowering the rear side windows makes it easier to position the paper strip.

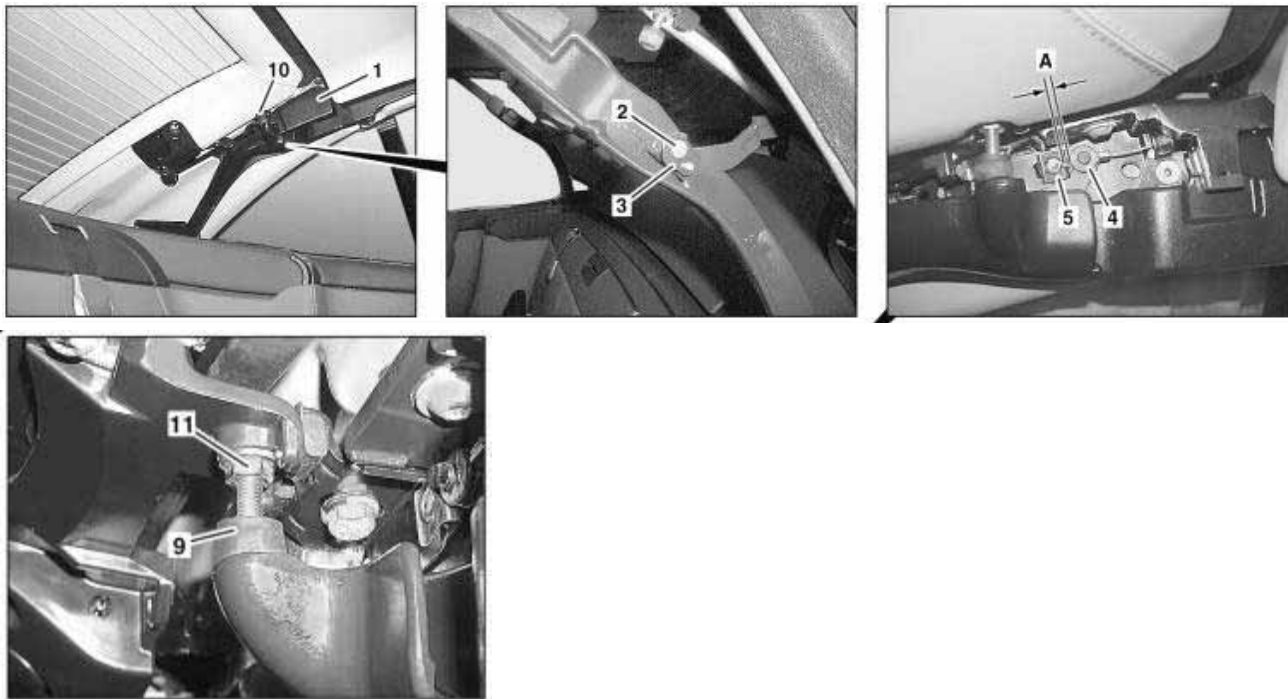
1.2.7 Area of locking cam on C-pillar

Complaint: Noises in the area of the locking cam.

Cause: Settling of the Vario roof after long periods of operation.

Action: Adjust cam (3), see AR77.50-P-3045R.

Important: If the setting of the cam (3) is changed, the setting of the rear window buffer (9) must be rechecked and corrected if necessary. The settings of the cam (3) and of the rear window buffer (9) influence each other.

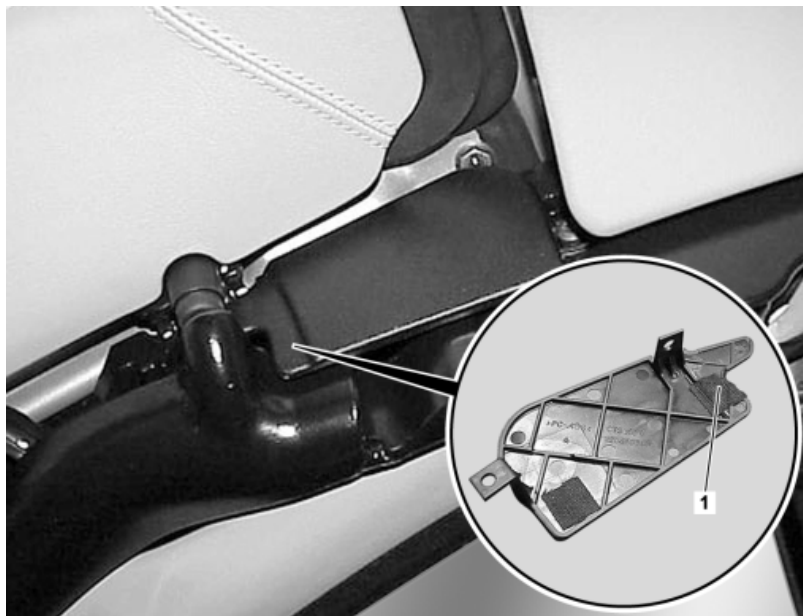
1.2.8 Area of lock cover on main guide

Complaint: Whirring noises in the area of the lock cover on the main guide.

Cause: Cover (1) touching the main guide.

Action: Remove cover, stick on a thin felt strip (1), part no. A 001 983 17 10, and reinstall the cover, see AF77.30-P-1509AG.

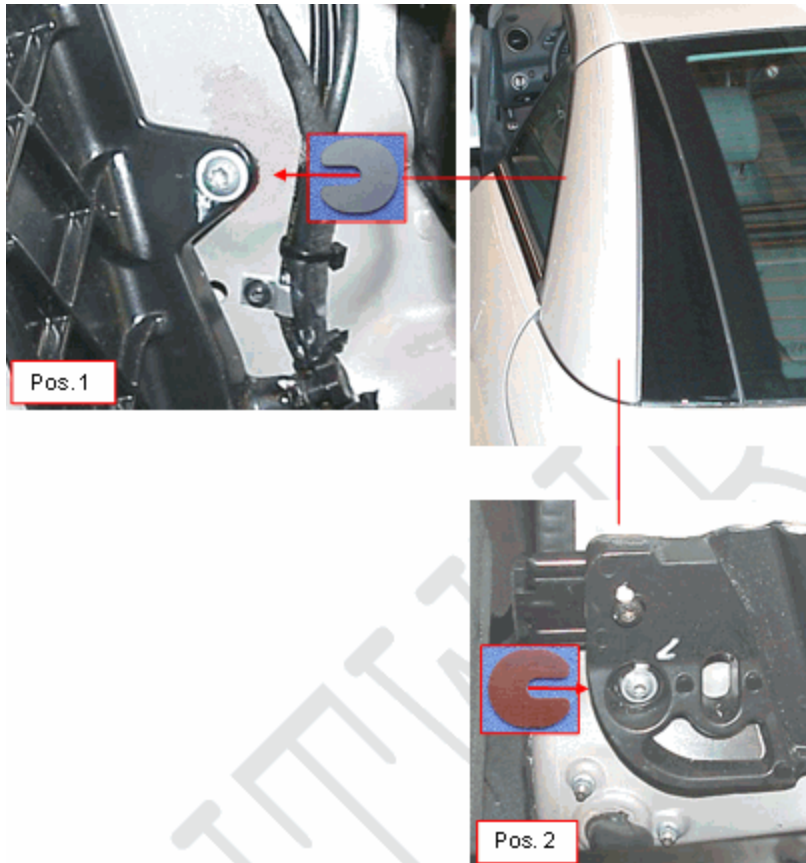
1.2.9 Area of C-pillar

Complaint: Tearing noises (crackling) in the area of the C-pillar.

Cause: C-pillar touching the mechanism.

Action: Shim the bolting points on the roof frame at the side (item 1) and bottom (item 2).

For item 1: 0.5 mm (steel) Part no. A 230 795 11 96
1 mm (steel) Part no. A 230 795 12 96

For item 2: 0.5 mm (brown) Part no. A 230 795 05 96
1 mm (brown) Part no. A 230 795 06 96

Thread locking agent: part no. A 003 989 31 71 must be used.

Tightening torque of bolts: 10 Nm

Note: Start with 0.5 mm shims; if the noises persist, use 1 mm shims.

Important: Check the adjustment of the rear window on the Vario roof and correct if necessary, see AR77.50-P-3045R and AR67.20-P-3000-06R.

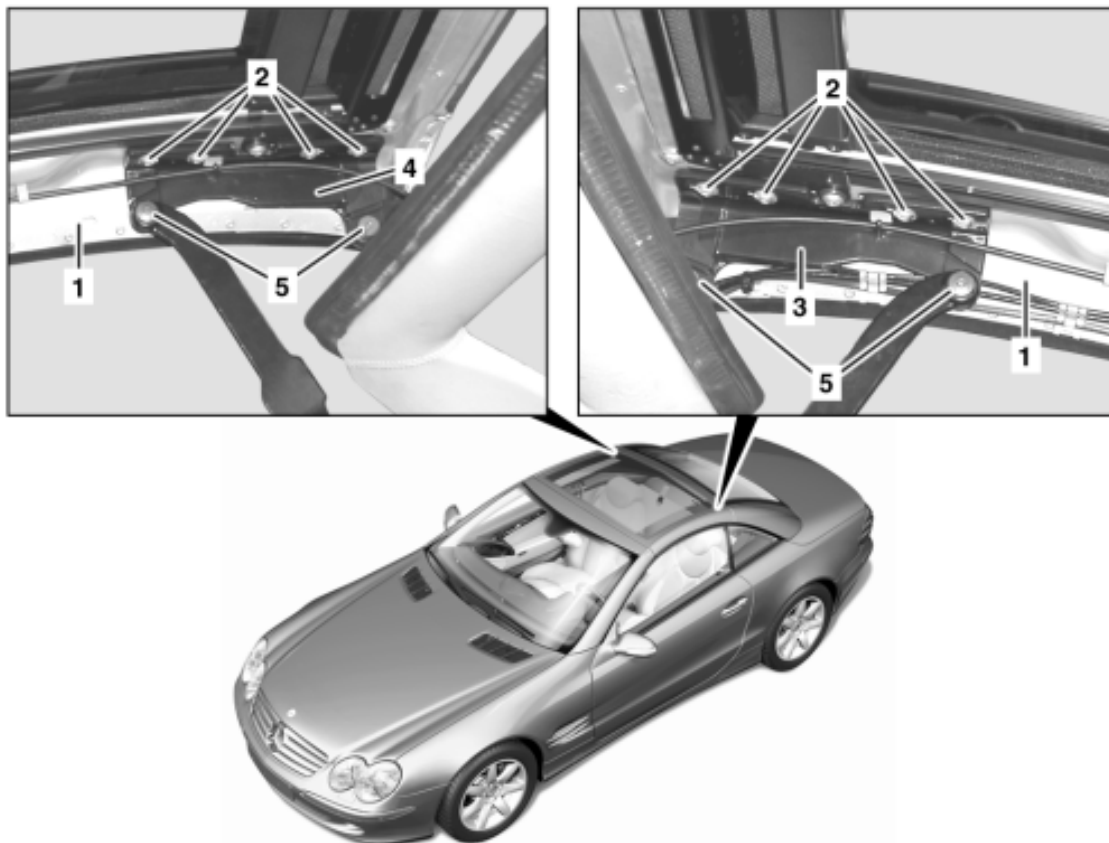
1.2.10 Area of bracket at front section of Vario roof

Complaint: Slight crackling in the area of the connection of the front section of the Vario roof.

Cause: Bracket (3/4) at front section of Vario roof under stress.

Action: **Before unscrewing the bolts, mark the position of the bracket relative to the front section of the Vario roof.**

Note: First slacken and retighten the two bolts at the rear, and then slacken and retighten the two bolts at the front.

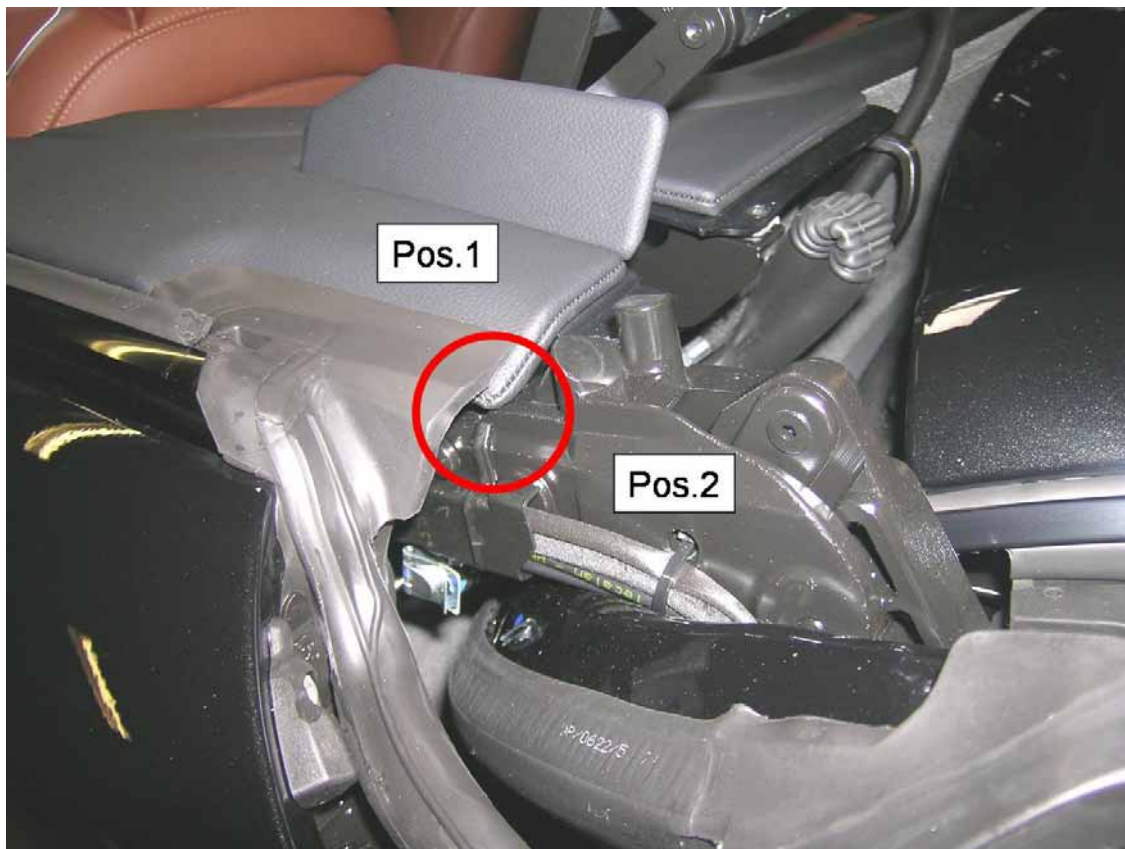
1.2.11 Area of center pillar paneling at the top

Complaint: Cracking noises between the center pillar paneling at the top and the Vario roof intermediate bearing.

Cause: Paneling (item 1) touching the intermediate bearing (item 2).

Action: Detach paneling and adjust to a higher position, see AR68.30-P-1077R.

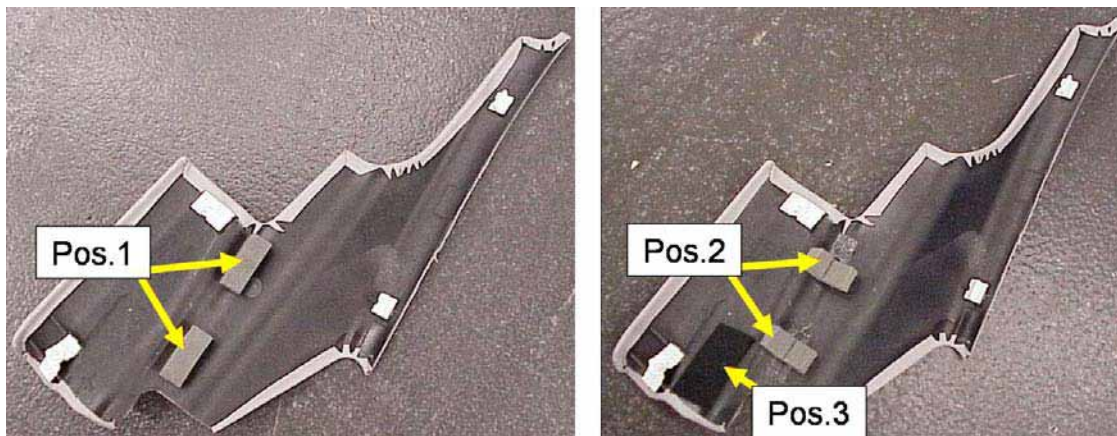
1.2.12 Area of paneling on Vario roof C-pillar

Complaint: Cracking noises/crackling between the C-pillar roof paneling and the Vario roof frame.

Cause: Roof paneling touching the roof frame.

Action: Remove paneling on C-pillar, see AR68.30-P-4500R.
Detach foam padding (item 1) and stick down in revised position (item 2). In addition, stick self-adhesive fabric tape (item 3), part no. A 000 983 99 13 7098, on the paneling.

Note: When assembling the C-pillar roof paneling, make sure that the clips are properly seated.

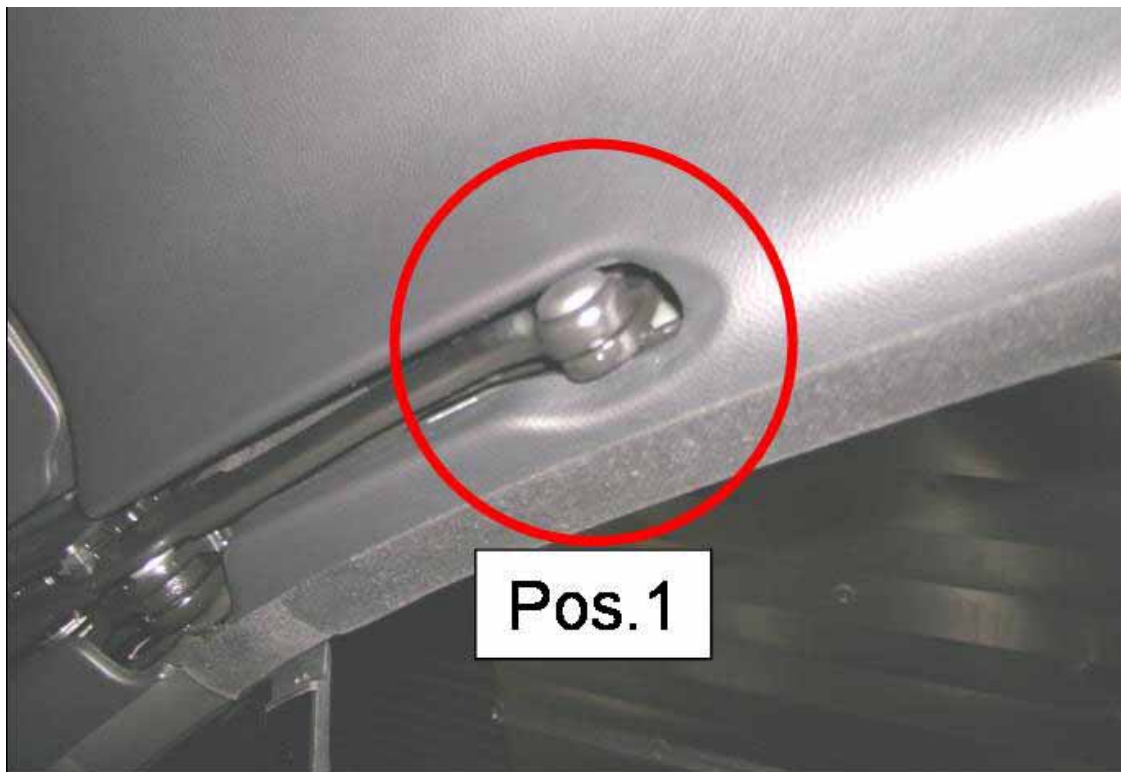
1.2.13 Area of roof paneling at pivot point 1

Complaint: Friction noises between roof paneling and pivot point 1.

Cause: Insufficient play between the pivot point (item 1) and the roof paneling.

Action: Reposition the roof paneling at the pivot point (item 1) and relieve the stress by tapping gently vertically upwards with the palm of your hand.

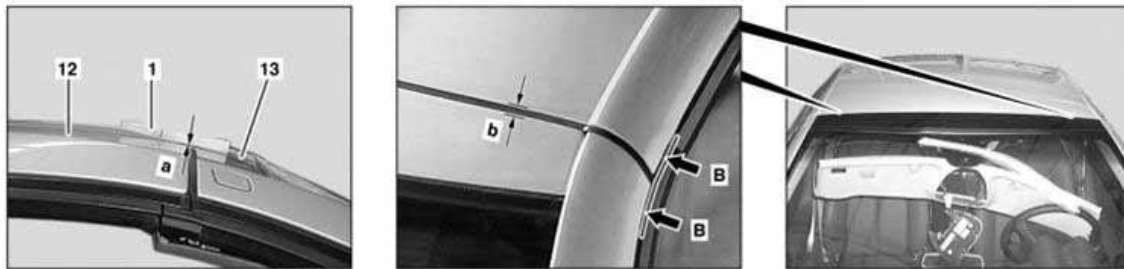
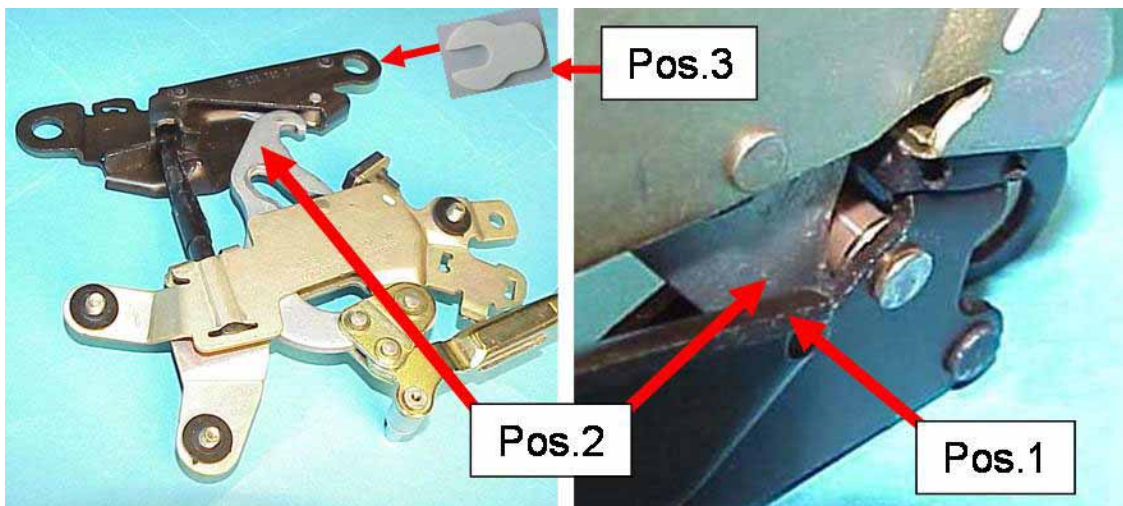
1.3.1 Area of windshield frame

Cause: Socket for Vario roof latch shifted forwards; the gap (b) between the front section of the Vario roof and the crossmember above the windshield gets wider.

Action: Adjust the gap between the Vario roof and the crossmember above the windshield, see AR77.50-P-3035R.
Adjust the socket (item 1) so that the latch hook (item 2) is in the center of the latch (item 1) and does not come into contact with the base when the Vario roof is locked, see AF77.30-P-1560AG.

Note: The installation position and part no. of the shims (item 3) have been changed. Install shims (item 3) in the direction of the arrow.

New part no. of shims: A 230 795 14 96

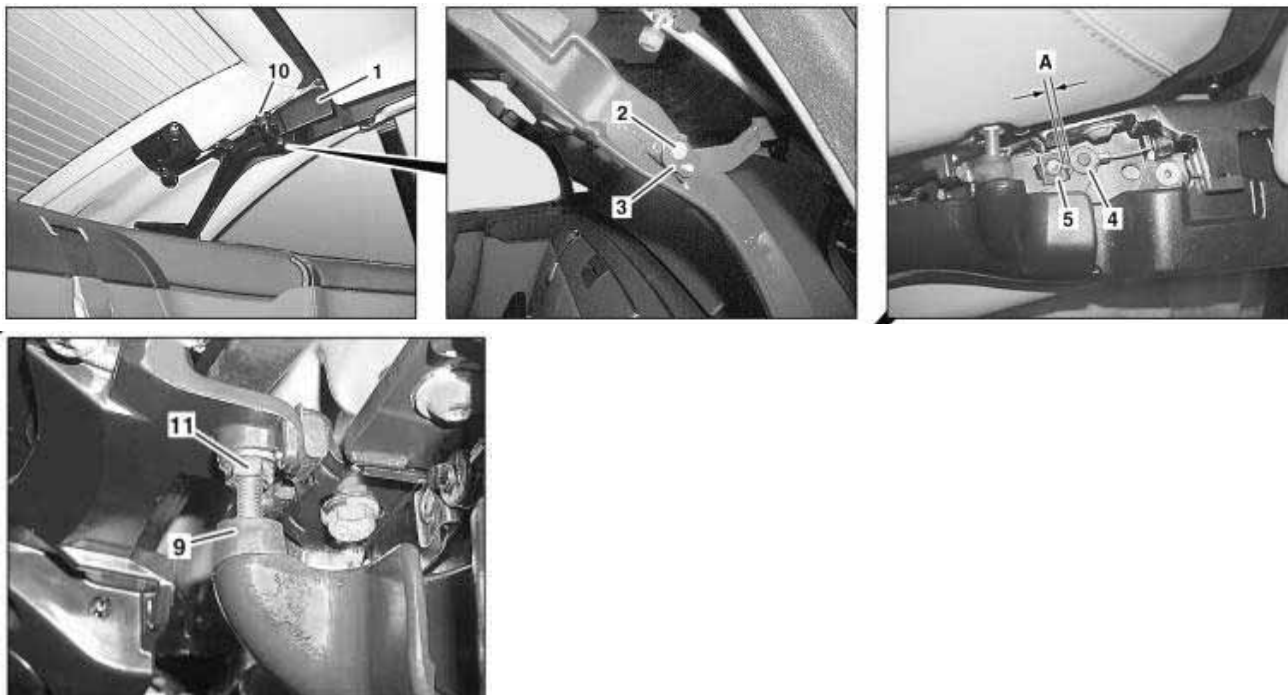
1.3.2 Wind noises occurring suddenly in area of Vario roof at center/rear

Complaint: Wind noises occurring suddenly at speeds above approx. 150 km/h.

Cause: Adjustment of C-pillar lock cam not OK.

Note: At high speeds the Vario roof can be pulled up in the area of the top edge of the rear window (A).

Action: Adjust cam (3), see AR77.50-P-3045R.

Important: If the setting of the cam (3) is changed, the setting of the rear window buffer (9) must be rechecked and corrected if necessary. The settings of the cam (3) and of the rear window buffer (9) influence each other.

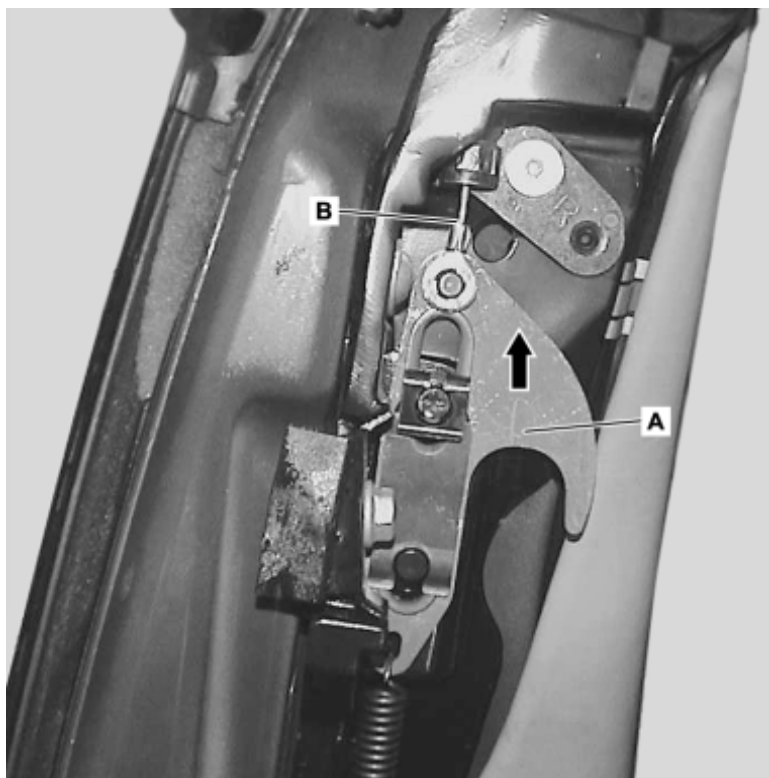
1.4.1 Area of lock on front of C-pillar

Complaint: Snapping noises/whirring from the area of the lock cam on the C-pillar when opening the Vario roof.

Cause: Adjustment of the Bowden cables not OK.

Action: Adjust Bowden cable (B) for lock on C-pillar, see AR77.33-P-3470R.

Note: Adjust the Bowden cable (B) so that the lock (A) is pulled upwards (arrow) when the Vario roof is in the intermediate position.

Important: Do not adjust it all the way to the stop otherwise the sleeve of the Bowden cable will be crushed (leave a gap of approx. 2 mm at the top).

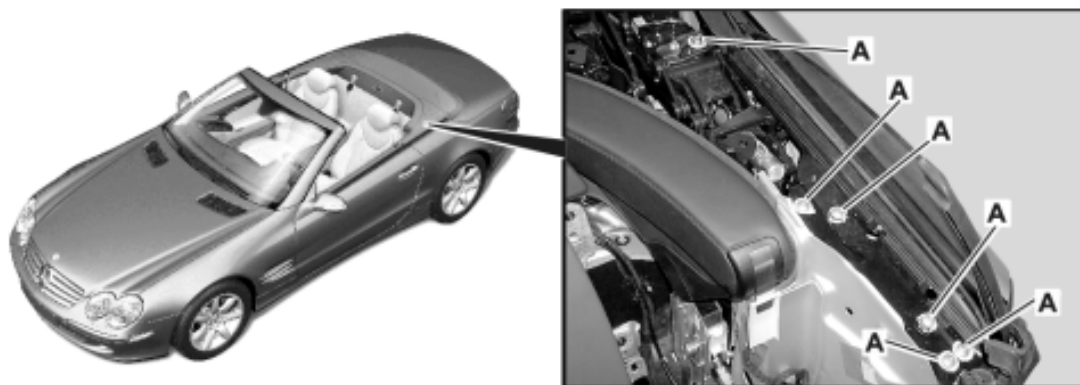
1.5.1 Area of rear window lifter retaining plate

Complaint: Cracking noises in the area of the window lifter retaining plate.

Cause: Unfavorable surface pairing between retaining plate and bodyshell.

Action: Remove paneling at top of center pillar. Mark bolt heads (A), slacken bolts, coat contact surfaces on underside of retaining plate with lubricant paste, part no. A 001 989 46 51, and retighten bolts, see AF77.30-P-1510AG.

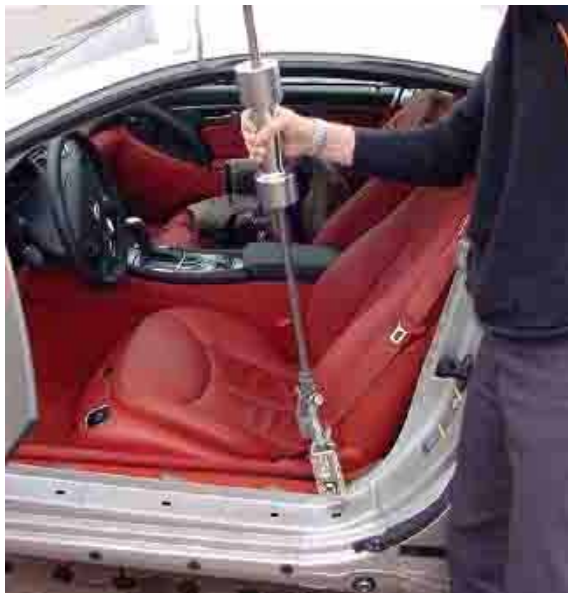
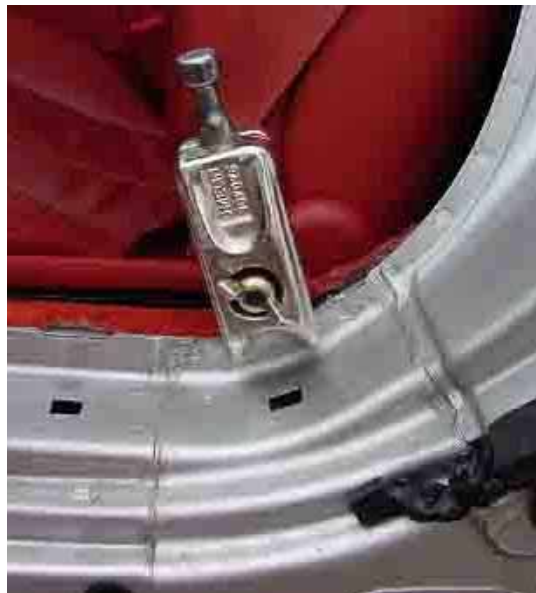
1.5.2 Creaking noise in area of B-pillar.

Complaint: Dry creaking noise in the area of the B-pillar when moving off or decelerating.

Cause: Stay panel within radius of inside of B-pillar produces a creaking noise.

Action: See GI63.20-P-009271*.

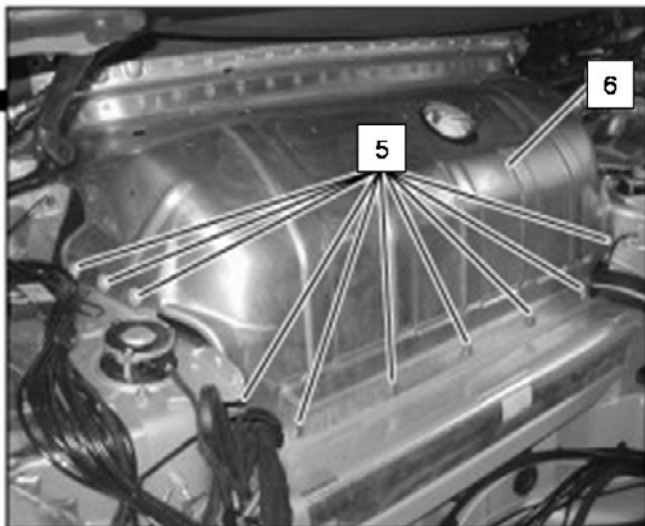
1.5.3 Cracking noises from area of trunk/Vario roof C-pillar

Complaint: Cracking/tearing noises from the area of the trunk.

Cause: Torque decrease at the threaded connections (item 5) of the tank cover (item 6) in the trunk.

Note: This cracking noise can also be transmitted to the area of the C-pillar of the Vario roof, and is therefore often attributed to the Vario roof.

Action: Slacken and retighten all the threaded connections (item 5), see GI68.64-P-038205*.

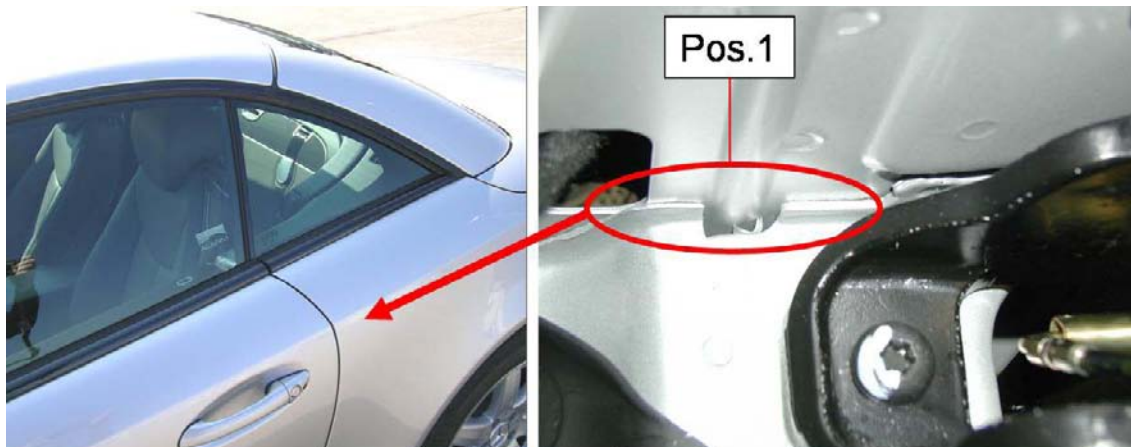
1.5.4 Cracking noises from area of B-pillar

Complaint: Cracking/tearing noise from the area of the B-pillar as the vehicle twists on rough roads.

Cause: Upright flange (item 1) of main bearing base mounting touching inner wall of B-pillar.

1. Remove paneling on center pillar, see AR68-30-P-1077R.
2. Use appropriate tools to bend the upright flange (item 1) of the main bearing base mounting away so that it is no longer in contact with the inner wall of the B-pillar. If the paint is damaged, apply anticorrosion agent, see GI 63.20-P-038600*.
