Released fold seam tension cable

P77.31-2240-01

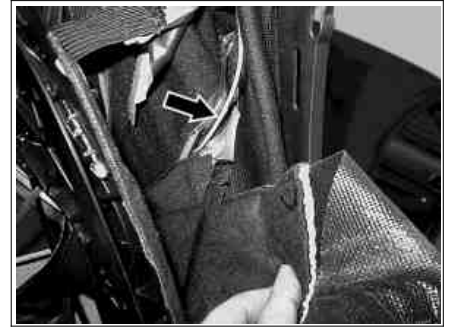
When closed the soft top canvas is not pulled at the side under the edge of the rear wall window.

Shown on the left water pocket, if necessary carry out the scope of the work on the right-hand side.	SM77.31-P-0001-02A
3	Glue fold seam to tension cable		SM77.31-P-0002-01A
4	Assemble water pocket		SM77.31-P-0001-02A
