MODEL 230.4 except CODE (P99) "AMG Black Series" special model

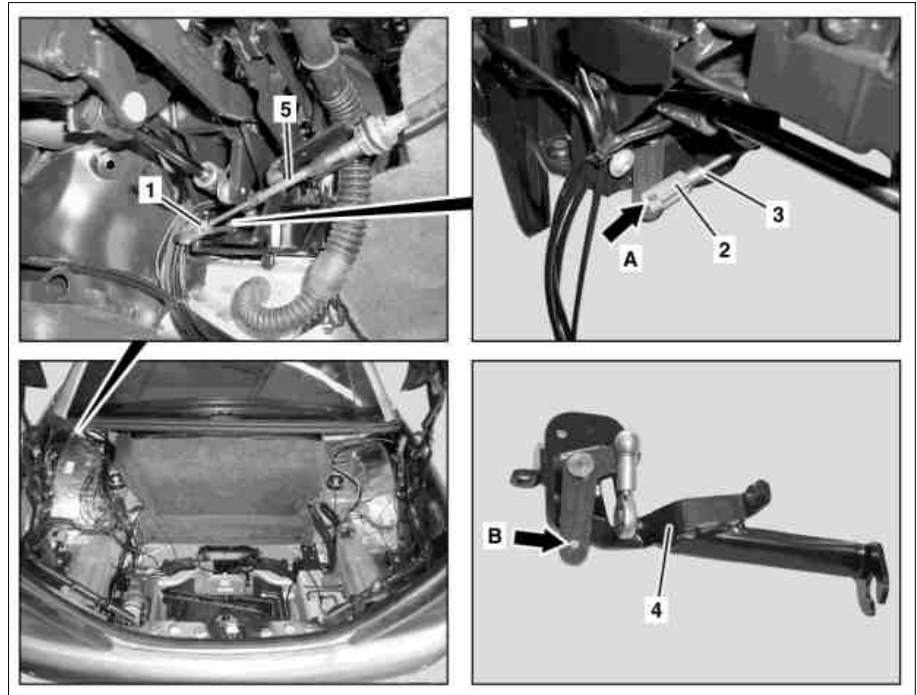
P77.30-2371-06

- 1 Spring flap bolt
- 2 Clevis
- 3 Jam nut
- 4 Operating cable drive
- 5 Operating cable

Removing		
Danger!	Risk of injury caused by moving parts that can pinch, crush or, in extreme cases, even sever extremities	No parts of the body or limbs should be within the operating range of the mechanism when moving components.	AS00.00-Z-0009-01A
1	Remove left side paneling in trunk		AR68.30-P-4800R
2	Remove spring flap bolt (1) from clevis (2) of operating cable (5)		
3	Loosen counternut (3) on clevis (2)		
	Adjust		
4	Adjust clevis (2) until eye (arrow A) is flush with hole (arrow B) on operating cable drive (4)		
5	Turn clevis (2) two turns to right and tighten counternut (3).		
6	Move Vario roof approx. 5 cm below load assist position with Vario roof switch		
	Install		
7	Insert spring flap bolt (1) into clevis (2) and secure	Slightly fold in/out compensating strips on Vario roof rear shelf to facilitate installation. Replace damaged spring flap bolt (1)	
8	Completely close Vario roof with Vario roof switch and check whether compensating strips locks on Vario roof rear shelf; repeat adjustment if necessary.
