MODEL 203 except CODE (581) Comfort automatic air conditioning

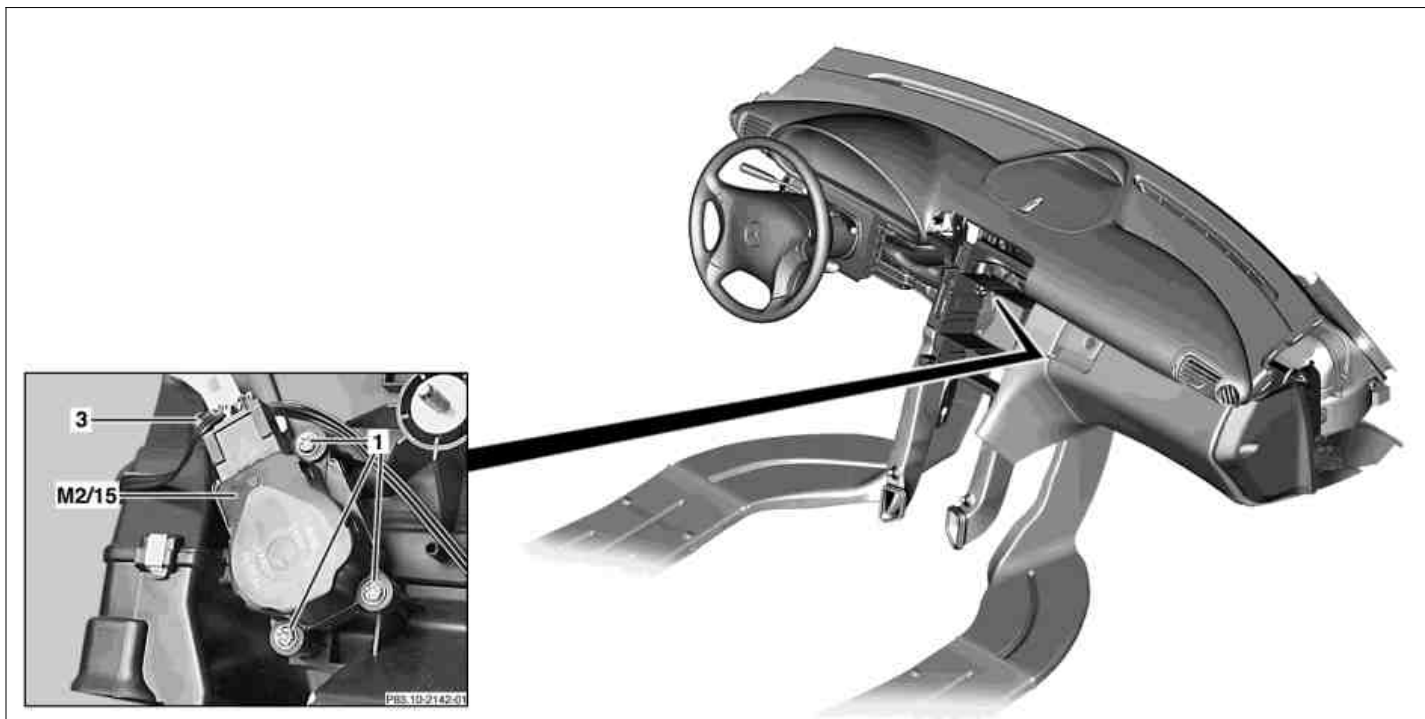
P83.10-2143-09

1 Bolts

3 Clutch

M2/15 Left and right footwell flaps actuator motor

- 1 Bolts
- 2 Offset screwdriver
- 3 Clutch
- 4 Instrument panel carrier
- M2/15 Left and right footwell flaps actuator motor

Remove/install		
1	Remove bottom section of dashboard on driver's side		AR68.10-P-1505P
2	Remove left air duct		
3	Remove bolt (1)	Torx offset screwdriver set: gotis://G_58.3_06.1	
4	Remove left and right footwell flaps actuator motor (M2/15) from heater/AC housing		
5	Disconnect connector (3) from left and right footwell flap actuator motor (M2/15)		
6	Install in the reverse order		
7	Synchronize left and right footwell flaps actuator motor (M2/15)		
	Connect STAR DIAGNOSIS and read out fault memory		AD00.00-P-2000-04A
