MODEL 203 with CODE (581) Comfort automatic air conditioning

P83.10-2151-09

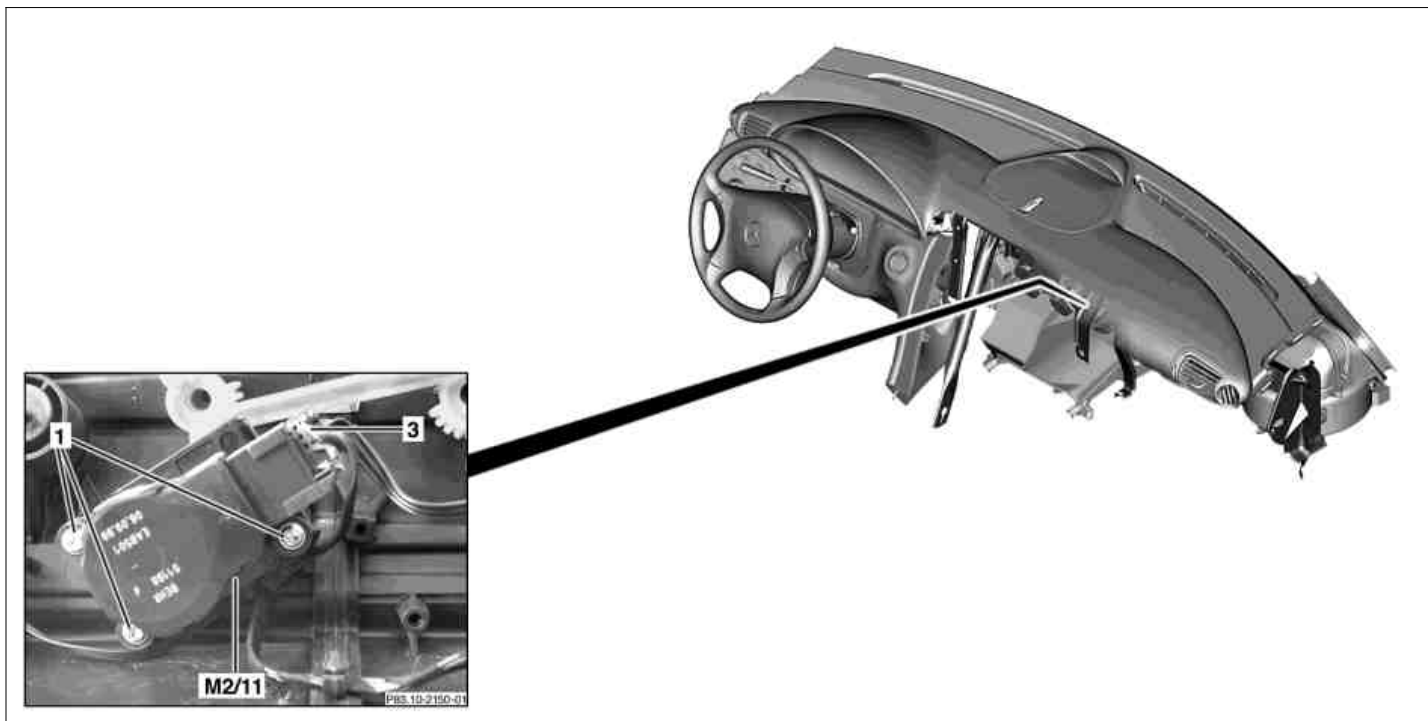
Shown on model 203.0

1 Bolts 3 Clutch M2/11 Right footwell flap actuator motor

Remove/install		
1	Remove glove compartment		AR68.10-P-1400P
2	Remove sound-proofing measure		
3	Remove bolts (1)

Remove three bolts (1).	
4	Remove right footwell flap actuator motor (M2/11) from AC housing		
5	Disconnect connector (3) from right footwell flap actuator motor (M2/11)		
6	Install in the reverse order		
7	Synchronize right footwell flap actuator motor (M2/11)
