MODEL 209 with CODE (581b) Convenience automatic air conditioning

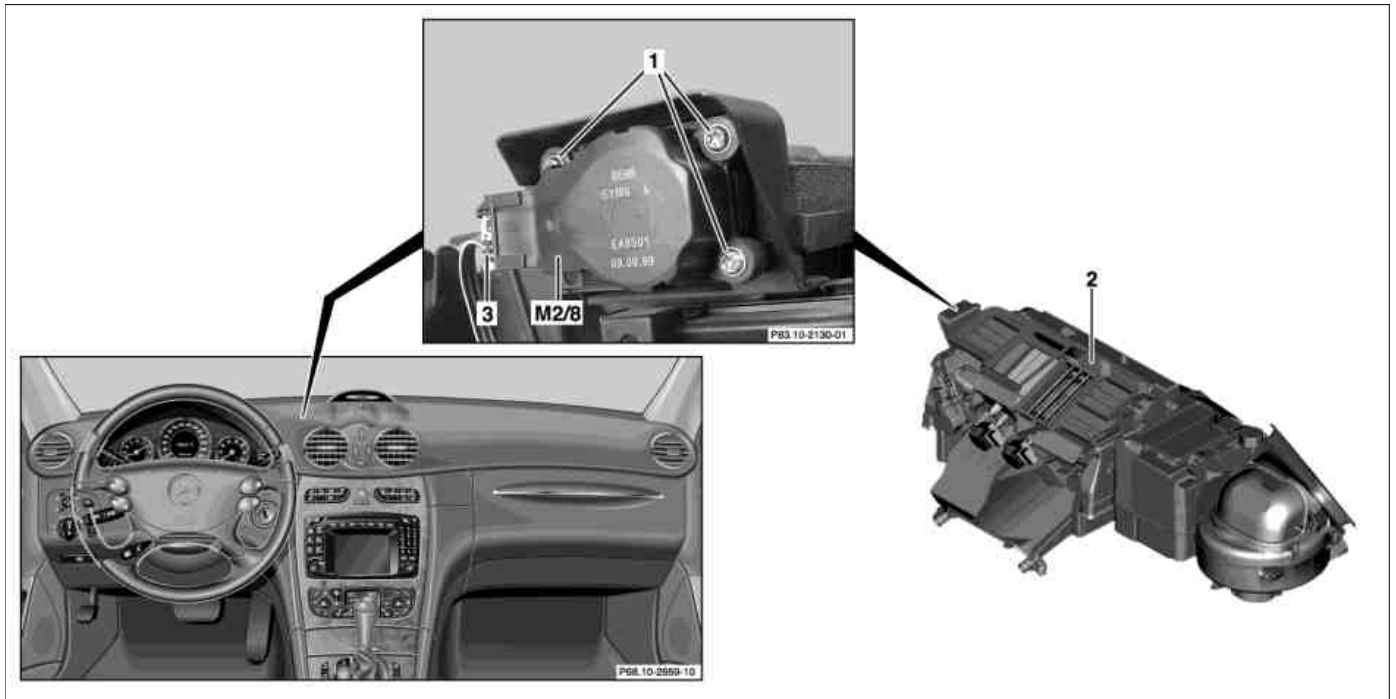
P83.10-2255-09

- 1 Bolts
- 2 AC housing

- 3 Electrical connector

- M2/8 Left defroster vent flap actuator motor

Remove/Install		
1	Remove instrument panel		AR68.10-P-1000Q
2	Remove bolts (1)		
3	Detach left defroster vent flap actuator motor (M2/8)		
4	Separate electrical connection (3)		
5	Install in the reverse order		
6	Connect STAR DIAGNOSIS, normalize left defroster vent flap actuator motor (M2/8), read out and erase fault memory Connect STAR DIAGNOSIS and read out fault memory	Diagnosis system STAR DIAGNOSIS	AD00.00-P-2000-04A *WH58.30-Z-1048-13A
7	Perform function check
