Illustrated on model 209.4

Rear window

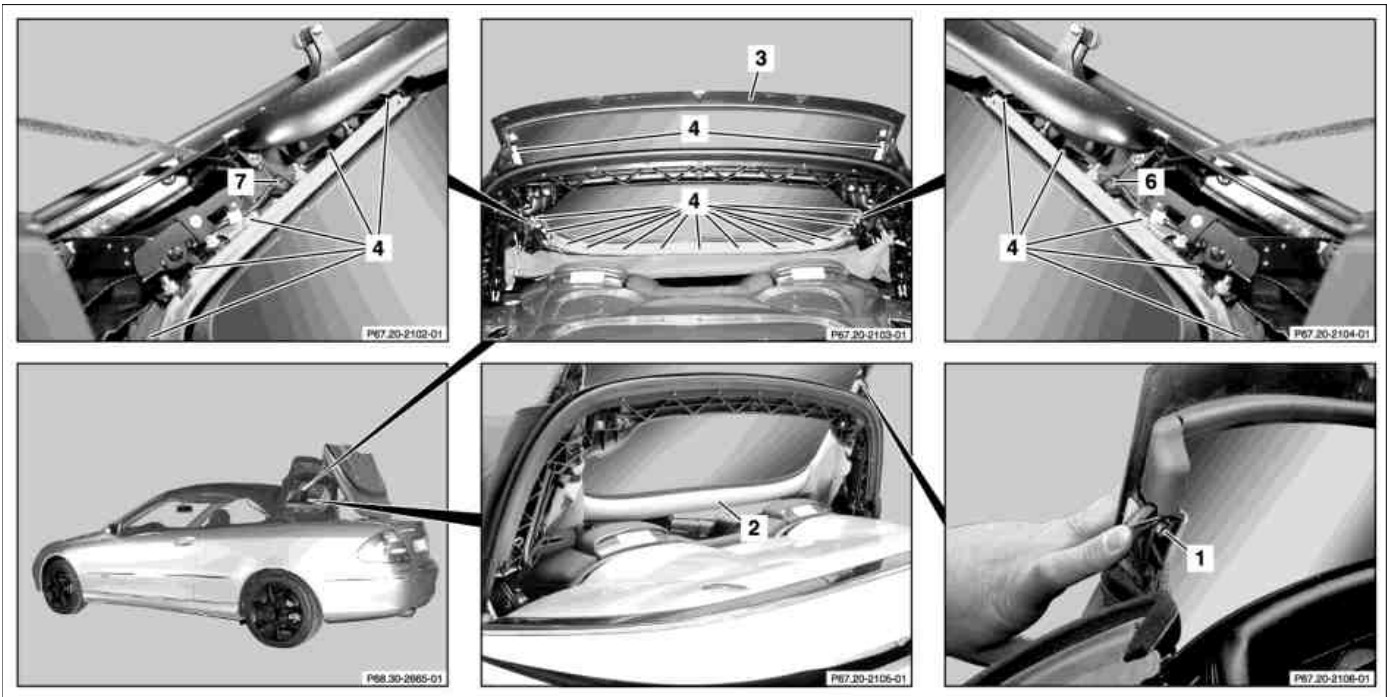
P67.20-2107-09

- 1 Nut
- 2 Headliner

- 3 Rear window
- 4 Nuts

- 6 Rear window heater coupling
- 7 Rear window heater coupling

1	Set up soft top bow and open soft top compartment lid		
2	Unscrew nut (1) on both sides	Model 209.4	*BA67.20-P-1001-02B
3	Lift headliner (2) out of groove in area of rear window (3)	The edge stripping on the headliner (2) is fasted with five clips.	
4	Disconnect rear window heater couplings (6, 7) from rear window (3).		
5	Unscrew nuts (4)		*BA67.20-P-1001-02B
6	Lift rear window (3) upward out of frame and then remove	Lay rear window (3) down on suitable base	
7	Heat seal (5) on rear window (3) with hot air blower and scrape off	Replace seal (5) each time when removing the rear window (3), otherwise water can penetrate into the vehicle. New rear window (3) is delivered without seal (5). Sealing Hot air blower gotis://E_15/54_12.0	*BR00.45-Z-1055-01A
8	Install in the reverse order

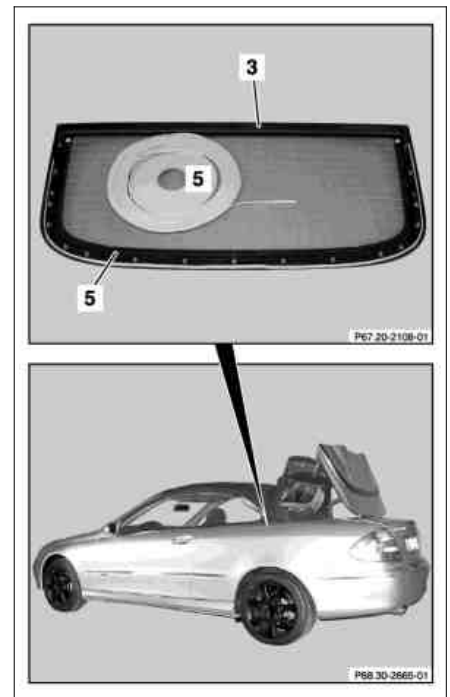
P67.20-2109-03

Illustrated on model 209.4

- 3 Rear window
- 5 Sealing
