P77.30-2105-09

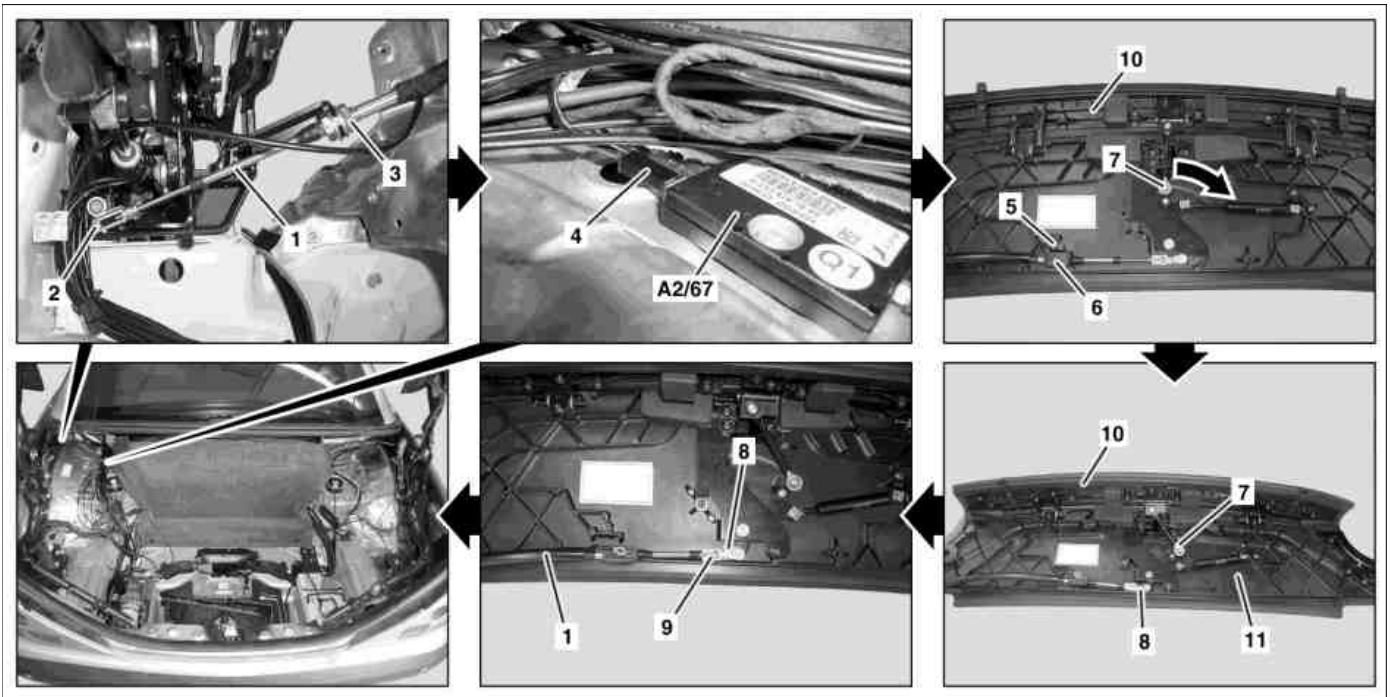
| 1 | Operating cable | 6 | Retaining plate | 10 | Compensating strip |
| 2 | Spring flap bolt | 7 | Shift rail | 11 | Rear shelf main flap |
| 3 | Nut | 8 | Spring flap bolt | A2/67 | Rear shelf antenna amplifier |
| 4 | Electrical connector | 9 | Control cable mount | | |
| 5 | Screw | | | | |

Remove/install		
1	Remove left side paneling in trunk		AR68.30-P-4800R
2	Remove spring flap bolt (2) at bottom end of operating cable (1).	i Installation: Check adjustment of operating cable (1), correct if necessary.	AR77.30-P-6345R
3	Loosen nut (3) and unhook operating cable (1).		
4	Disconnect electrical connector (4) from rear shelf antenna amplifier (A2/67)		
5	Complete remove Vario roof rear shelf		AR77.30-P-6340R AS60.00-Z-0006-01R
⚠ Danger!	Risk of fire and explosion caused by machining/treating magnesium components	Keep away from ignition sources and open flames.	
6	Unscrew bolt (5) and remove retaining plate (6).	Nm	*BA77.30-P-1006-01B AH60.00-P-0023-01R
ⓘ	Information on machining/treating magnesium components		
7	Move compensating strips (10) in 90° position to rear shelf main flap (11)	i For this purpose push shift rail (7) in direction of arrow and simultaneously fold in compensating strips (10). This provides sufficient space for removing spring flap bolt (8).

8	Remove spring flap bolt (8) and remove operating cable (1) from rear shelf main flap (11)	i Installation: The open side of the control cable mount (9) should be visible.	
9	Install in the reverse order
