MODEL 230.4 except CODE (P99) "AMG Black Series" special model

Trunk lid

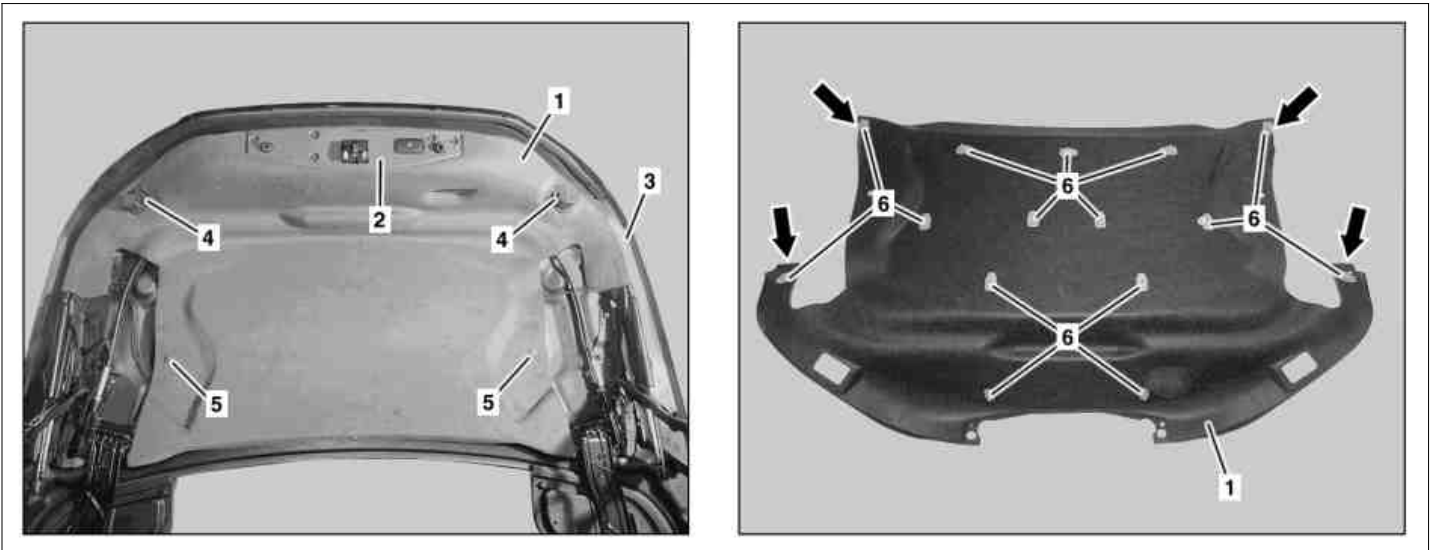
P68.30-3262-08

- 1 Trim
- 2 Cover
- 3 Trunk lid

- 4 Locking wedge
- 5 Expansion clip
- 6 Clip

Remove/install		
Danger!	Risk of injury caused by moving parts that can pinch, crush or, in extreme cases, even sever extremities	No parts of the body or limbs should be within the operating range of the mechanism when moving components.	AS00.00-Z-0009-01A
1	Completely open Vario roof		
2	Remove cover (2) from trunk lid (3)	Installation: Replace damaged expansion clips.	
3	Remove closing wedges (4) from trunk lid (3)		*BA88.50-P-1015-01A
4	Remove expansion clips (5)	Installation: Replace damaged expansion clips (5).	
5	Unclip paneling (1) from trunk lid (3) starting at outer clips (6) (arrows) and remove.	Position mounting wedge directly to corresponding clip (6) to unclip, to prevent damaging paneling (1). Installation: Replace damaged clips (6). 	*110589035900
6	Install in the reverse order		
7	Check trunk lid adjustment (3), correct if necessary	Vehicles up to end no.. 063909 Vehicles as of end no. 063910	AR88.50-P-5200R AR88.50-P-5200RA

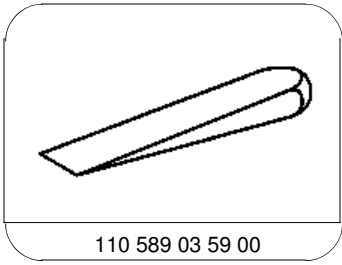
110 589 03 59 00

Mounting wedge
