MODEL 207.4, 209.4

| XX | Remove/install | | |

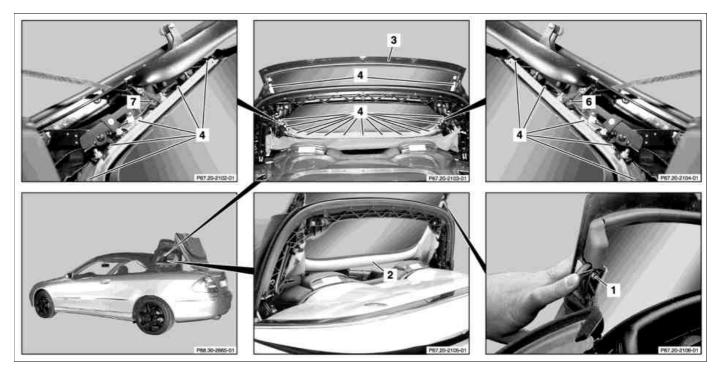
P67.20-2107-09

Illustrated on model 209.4

- 1 Nut
- 2 Headliner

- 3 Rear window
- 5 Sealing

- 3 Rear window
- 1 Nuts

Rear window heater couplingRear window heater coupling

| 1 | Set up soft top bow and open soft top compartment lid | | |
|---|--|---|---|
| 2 | Unscrew nut (1) on both sides | Nm Model 209.4 | *BA67.20-P-1001-02B |
| 3 | Lift headliner (2) out of groove in area of rear window (3) | The edge stripping on the headliner (2) is fasted with five clips. | |
| 4 | Disconnect rear window heater couplings (6, 7) from rear window (3). | | |
| 5 | Unscrew nuts (4) | Nm | *BA67.20-P-1001-02B |
| 6 | Lift rear window (3) upward out of frame and then remove | Lay rear window (3) down on suitable base | |
| 7 | Heat seal (5) on rear window (3) with hot air blower and scrape off | Replace seal (5) each time when removing the rear window (3), otherwise water can penetrate into the vehicle. New rear window (3) is delivered without | |
| | | seal (5). | |
