MODEL 203, 209, 463.202 /222 /236 /237 /243 /244 /245 /246 /247 /248 /249 /250 /254 /270 /271 /303 /309 /322 /323 /332 /333 /340 /341

Shown on model 203.7 up to 23.4.04

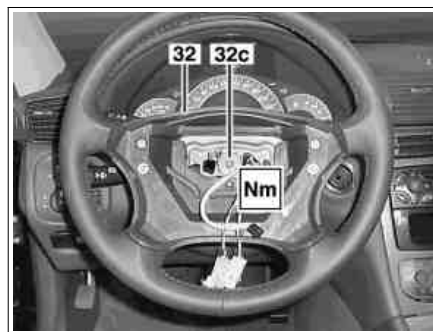
P46.10-2163-01

- 32 Steering wheel
- 32c Countersunk screw

Installation: Replace countersunk bolt (32c).

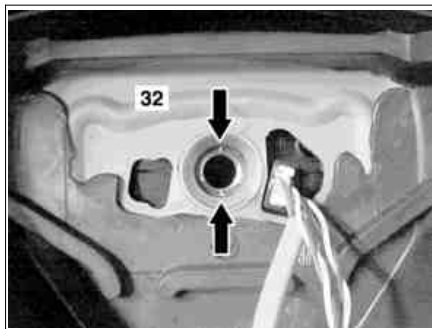
P46.10-2162-01

32 Steering wheel

A45 Fanfare horns and airbag clock spring contact

Checking		
10	Check fanfare horns and airbag clock spring contact (A45) for damage	Only on model 203 up to 30.6.02, Model 203 as of 1.7.02 up to 23.4.04, Model 209 up to 31.5.04, Model 203 as of 24.4.04, Model 209 as of 1.6.04, Model 463.243/244/245/246/247/248/249/250/254/309/322/323/332/333 up to 31.5.04

If damaged, replace fanfare horns and airbag clock spring contact (A45): ↓ Model 203 up to 30.6.02 Remove/install clock spring contact Model 203 as of 1.7.02 up to 23.4.04 Model 209 up to 31.5.04 Remove/install clock spring contact Model 203 as of 24.4.04 Model 209 as of 1.6.04 Remove/install clock spring contact Model 463.243/244/245/246/247/248/249/250/254/309/322/323/332/333 up to 31.5.04 Remove/install clock spring contact	AR46.10-P-0200P AR46.10-P-0200Q AR46.10-P-0200PQ AR46.10-P-0200GS

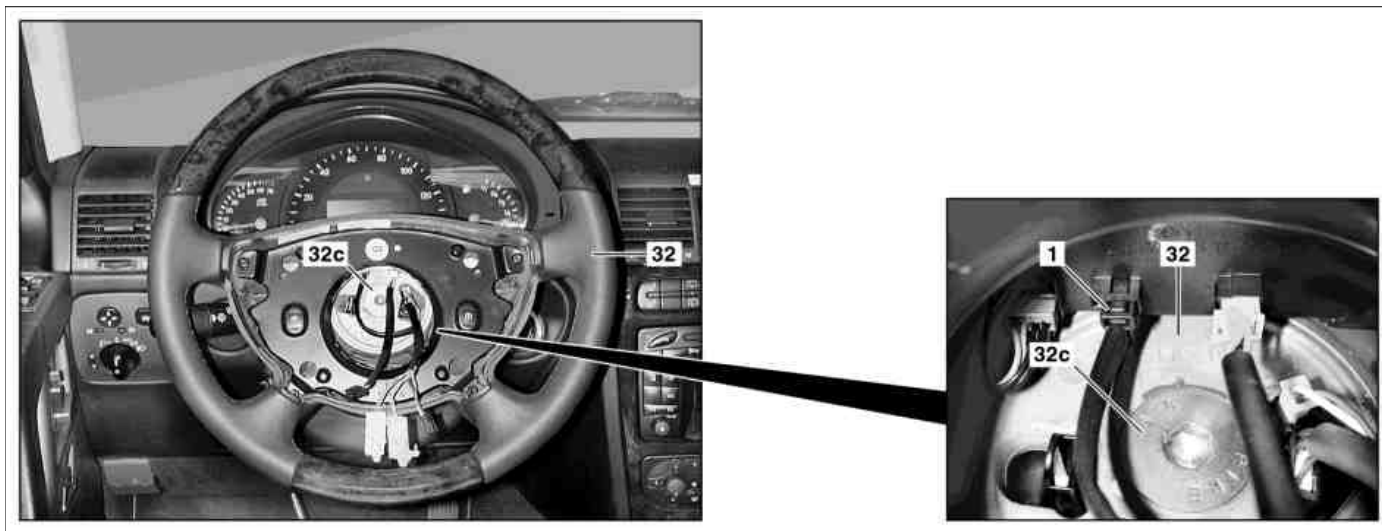
P46.10-2327-08

Shown on model 463 as of 1.7.02

- 1 Electrical connection of steering wheel heater
- 32 Steering wheel
- 32c Countersunk screw
