MODEL 230.4 except CODE (P99) "AMG Black Series" special model

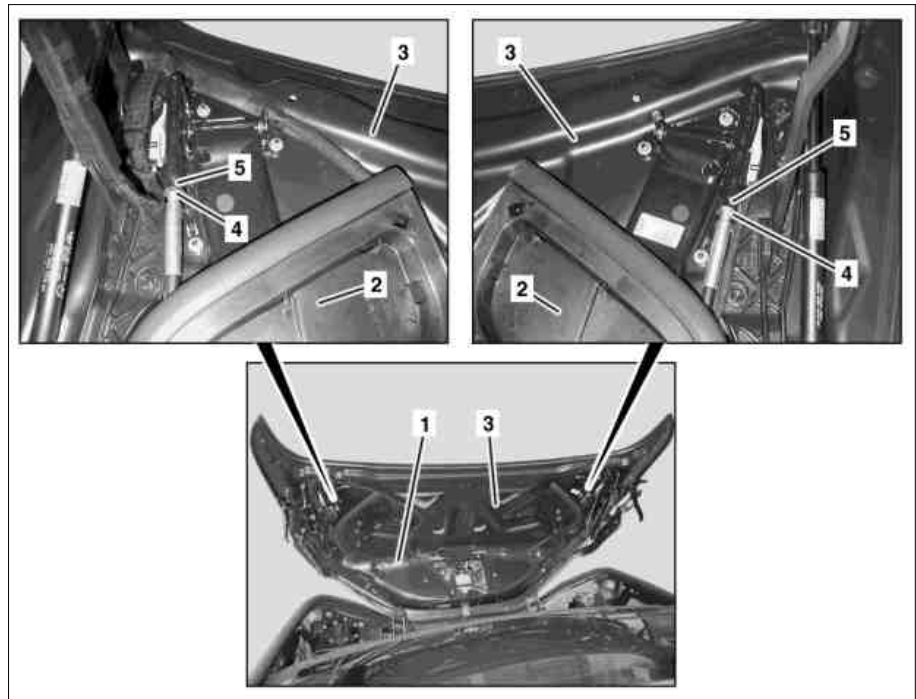
P77.30-2113-06

- 1 Side flap drive
- 2 Side flap
- 3 Trunk lid
- 4 Jam nut
- 5 Adjusting nut

Checking		
⚠ Danger!	Risk of injury caused by moving parts that can pinch, crush or, in extreme cases, even sever extremities	No parts of the body or limbs should be within the operating range of the mechanism when moving components.	AS00.00-Z-0009-01A
i	Correct adjustment of the side flap drive (1) allows uniform motion of the two side flaps (2). Moreover, it prevents that the side flaps (2) cause noises when the Vario roof is opened. Only adjust side flap (2) not in contact with the inside of the trunk lid (3), because the side flap drive (1) switches off as soon as the side flap (2) makes contact.		
1	Open trunk lid (3)	i With Vario roof closed.	
2	Check adjustment of side flap drive (1).	i Side flaps (2) are folded in. Both side flaps (2) should make uniform contact with inside of trunk lid (3) under slight tension.	
	Adjust		
3	Loosen jam nut (4) and turn adjustment bolt (5)	⚙ Carefully turn adjusting nut (5) at small increments. Otherwise the side flap drive (1) can be damaged. i Only adjust side flap (2) not making contact with trunk lid (3). Turn adjusting nut (5) until side flap (2) makes contact with inside of trunk lid (3) under slight tension.

4	Tighten lock nut (4).		
	Checking		
5	Close trunk lid (3)		
6	Completely open and close Vario roof		
7	Open trunk lid (3) and check adjustment of side flap drive (1), if applicable repeat adjustment procedure.	i With Vario roof closed. After readjusting, completely open and close Vario roof before checking.	
8	Repair paint damage on adjustment nut (5)
