MODEL 209

M2/6 Left blended air flap positioning motor

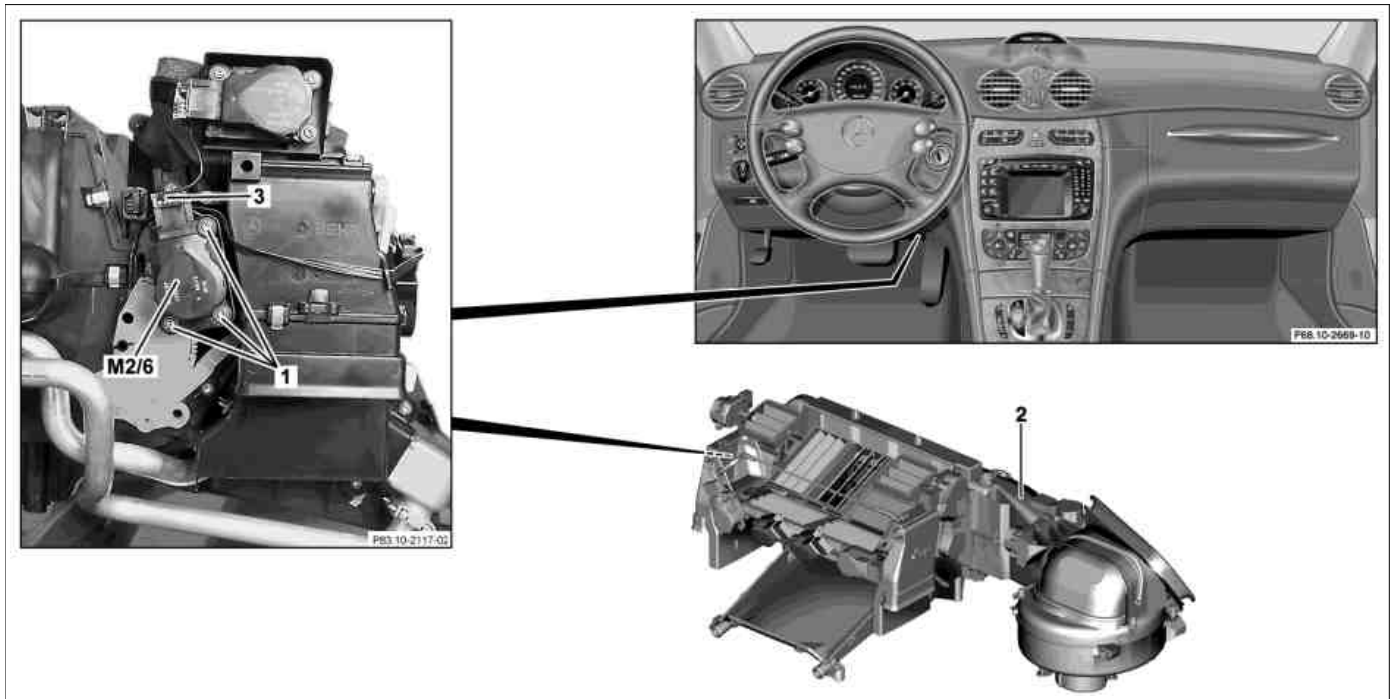
P83.10-2251-09

1 Bolts
2 AC housing

3 Electrical connector

Remove/Install		
1	Remove cover below left of instrument panel	AR68.10-P-1500P
2	Remove bolts (1)	
3	Remove left blending air flap actuator motor (M2/6)	
4	Separate electrical connection (3)	
5	Install in the reverse order	
6	Connect STAR DIAGNOSIS, normalize left blending air flap actuator motor (M2/6), read out fault memory and delete Connect STAR DIAGNOSIS and read out fault memory	AD00.00-P-2000-04A *WH58.30-Z-1048-13A
7	Perform function check
