MODEL 209 with CODE (581b) Convenience automatic air conditioning

- M2/9 Right defroster vent flap actuator motor

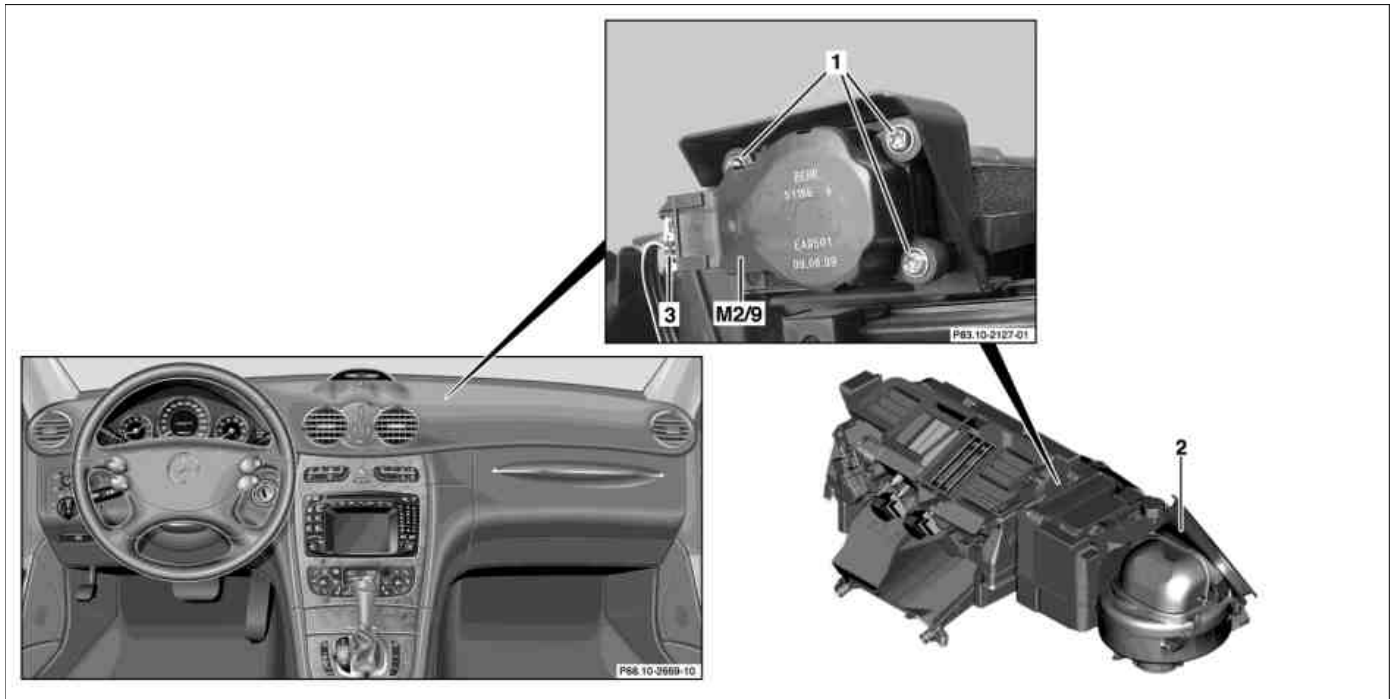
P83.10-2257-09

- 1 Bolts
- 2 AC housing

- 3 Electrical connector

Remove/Install		
1	Remove instrument panel	AR68.10-P-1000Q
2	Expose electrical wiring harness in area of right defroster vent flap actuator motor (M2/9)	
3	Remove bolts (1)	
4	Detach right defroster vent flap actuator motor (M2/9)	
5	Separate electrical connection (3)	
6	Install in the reverse order	
7	Connect STAR DIAGNOSIS, normalize right defroster vent flap actuator motor (M2/9), read out and erase fault memory Connect STAR DIAGNOSIS and read out fault memory	AD00.00-P-2000-04A *WH58.30-Z-1048-13A
8	Perform function check	Diagnosis system STAR DIAGNOSIS
