MODEL 209.3 with CODE (581) Convenience automatic air conditioning

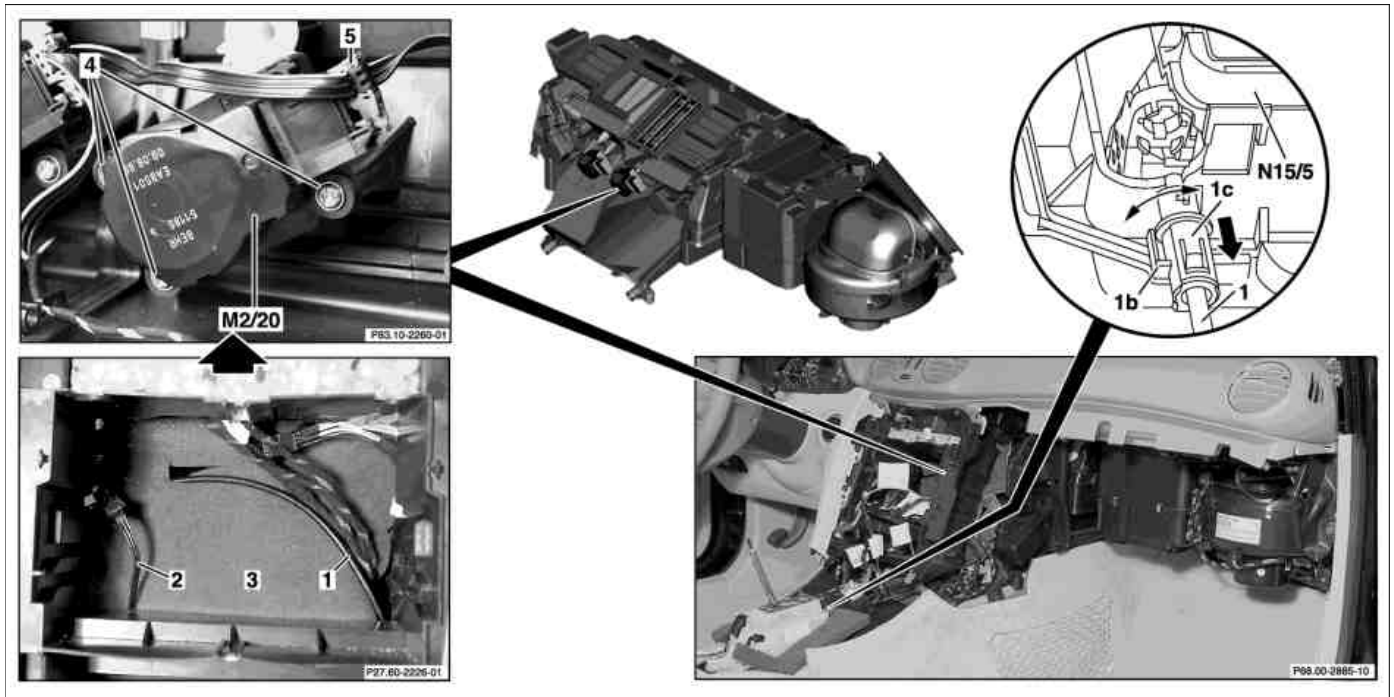
P83.10-2432-09

1 Ignition lock control cable
 1b Locating tab
 1c Clutch
 2 Electrical line

3 Vapor barrier
 4 Bolts
 5 Electrical connector

M2/20 Right fresh air flap positioning motor
 N15/5 Electronic selector lever module control unit

4.1	Remove ignition switch cable (1) from the electronic selector lever module control unit (N15/5)	On vehicles with transmission 722

Press locking tab (1b) together and push coupling (1c) against the spring force into the electronic selector lever module control unit (N15/5), twist through approx. 90° (right or left) and pull off ignition lock control cable (1) (arrow).
