MODEL 209 except CODE (581b) Convenience automatic air conditioning

M2/7 Right blended air flap positioning motor

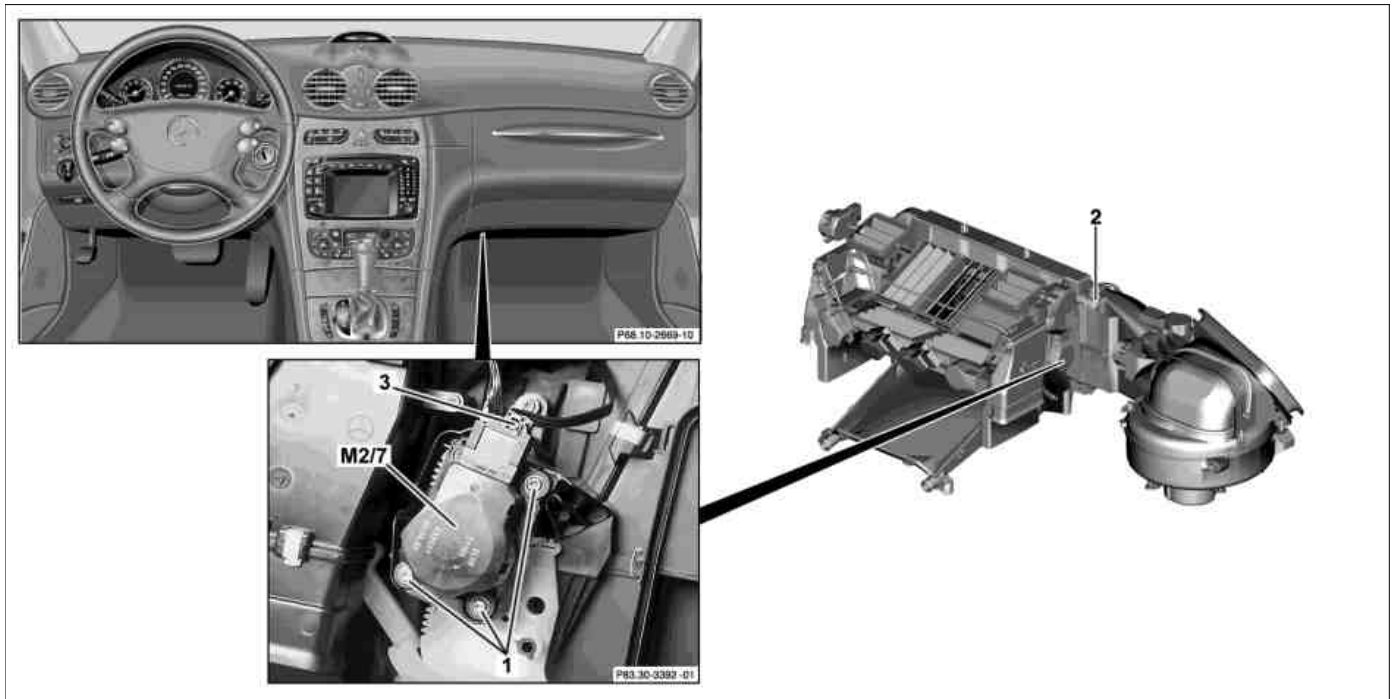
P83.10-2254-09

1 Bolts
2 AC housing

3 Electrical connector

Remove/Install		
1	Remove glove compartment		AR68.10-P-1400Q
2	Remove cover below instrument panel on passenger side		
3	Remove bolts (1)		
4	Detach right blending air flap actuator motor (M2/7)		
5	Separate electrical connection (3)		
6	Install in the reverse order		
7	Connect STAR DIAGNOSIS, normalize right blending air flap actuator (M2/7), read out and erase fault memory Connect STAR DIAGNOSIS and read out fault memory		AD00.00-P-2000-04A
		Diagnosis system STAR DIAGNOSIS	*WH58.30-Z-1048-13A
8	Perform function check
