MODEL 230.4 except CODE (P99) "AMG Black Series" special model

Test values for Vario roof gap dimensions

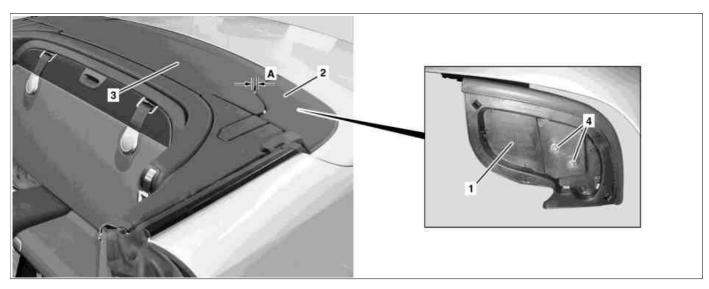
P77.30-2109-08

- 1 Side flap
 - Side flap cover

- 3 Rear shelf main flap
- 4 Bolts

A Gap dimension

4	Checking		
1	Fully open Vario roof using Vario roof switch		
2	Check gap (A) between rear shelf main flap (3) and side flap cover (2) with feeler gauge.		*BE77.30-P-1003-01A
		8	*129589032100
	Adjust		
3	Remove left and right side flap cover (2).		AR77.30-P-6379R
4	Loosen bolts (4)		
5	Lay side flap cover (2) down onto side flap (1) and uniformly adjust gap (A) over entire length of joint.		*BE77.30-P-1003-01A
	,	8	*129589032100
6	Remove side flap cover (2) and tighten bolts (4).	Nm	*BA77.30-P-1009-01B
7	Lay side flap cover (2) down onto side flap (1) and check gap (A) with feeler gauge,		*BE77.30-P-1003-01A
	repeat adjustment if necessary.	3	*129589032100
8	Install left and right side flap cover (2)		AR77.30-P-6379R
9	Check gap (A) with feeler gauge, repeat adjustment if necessary.		*BE77.30-P-1003-01A
		3	*129589032100

Number	Designation		Model 230
BE77.30-P-1003-01A	Gap between rear shelf and side flap	Dimension m	m 5,0
		See picture	-

BA77.30-P-1009-01B	Bolt, side flap to hinge	Nm	10
