Remove/install		
1	Remove bottom section of dashboard on driver's side		AR68.10-P-1505P
2	Remove left air duct		
3	Remove bolt (1)	Torx offset screwdriver set: gotis://G 58.3 06.1	
4	Remove left footwell flap actuator motor (M2/10) from heater/air conditioner housing		
5	Disconnect connector (3) from left footwell flap actuator motor (M2/10)		
6	Install in the reverse order		
7	Normalize left footwell flap actuator motor (M2/10)		
	Connect STAR DIAGNOSIS and read out fault memory		AD00.00-P-2000-04A

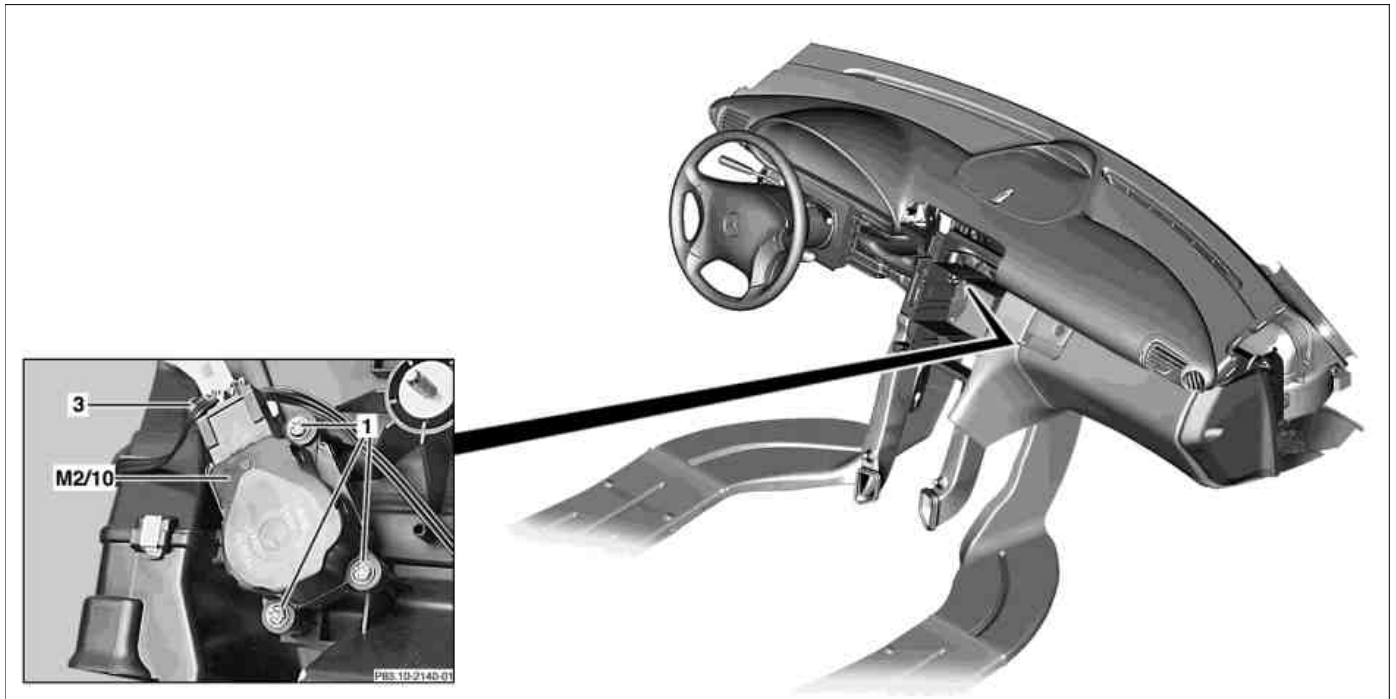
P83.10-2141-09

- 1 Bolts
- 1 Bolts
- 2 Offset screwdriver
- 3 Clutch
- 4 Instrument panel carrier
- M2/10 Left footwell flap actuator motor

3 Clutch

M2/10 Left footwell flap actuator motor
