**MODEL 209**

**with CODE (404) Orthopedic driver seat backrest (multicontour backrest in model 140), left  
with CODE (405) Orthopedic driver seat backrest (multicontour backrest in model 140), right**

**Shown on model 209.3**

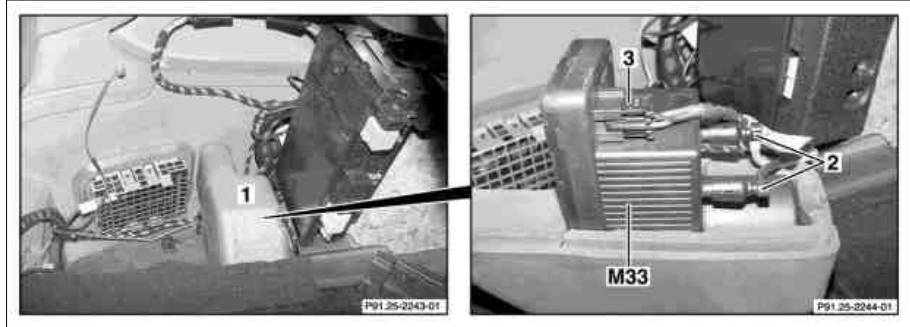
P91.25-2245-04

- 1 *Damping material*
- 2 *Pneumatic lines*
- 3 *Electrical connector*

- M33 *Electric air pump*

<b>Remove/install</b>		
		1 Remove left side trim in trunk	Model 209.3 Model 209.4	AR68.30-P-4600PB <b>AR68.30-P-4600QA</b>
2		Remove electrical air pump (M33) with damping (1) upwards		
3		Remove damping (1) from the electrical air pump (M33)		
4		Remove pneumatic lines (2) from the electrical air pump (M33)	Inspect connections of the pneumatic lines (2) for damages.	
5		Disconnect electrical connector (3) from electrical air pump (M33)		
6		Remove electrical air pump (M33) from the luggage compartment		
7		Install in the reverse order		
8		Carry out function check
