MODEL 209.3 with CODE (581) Convenience automatic air conditioning

P83.10-2259-09

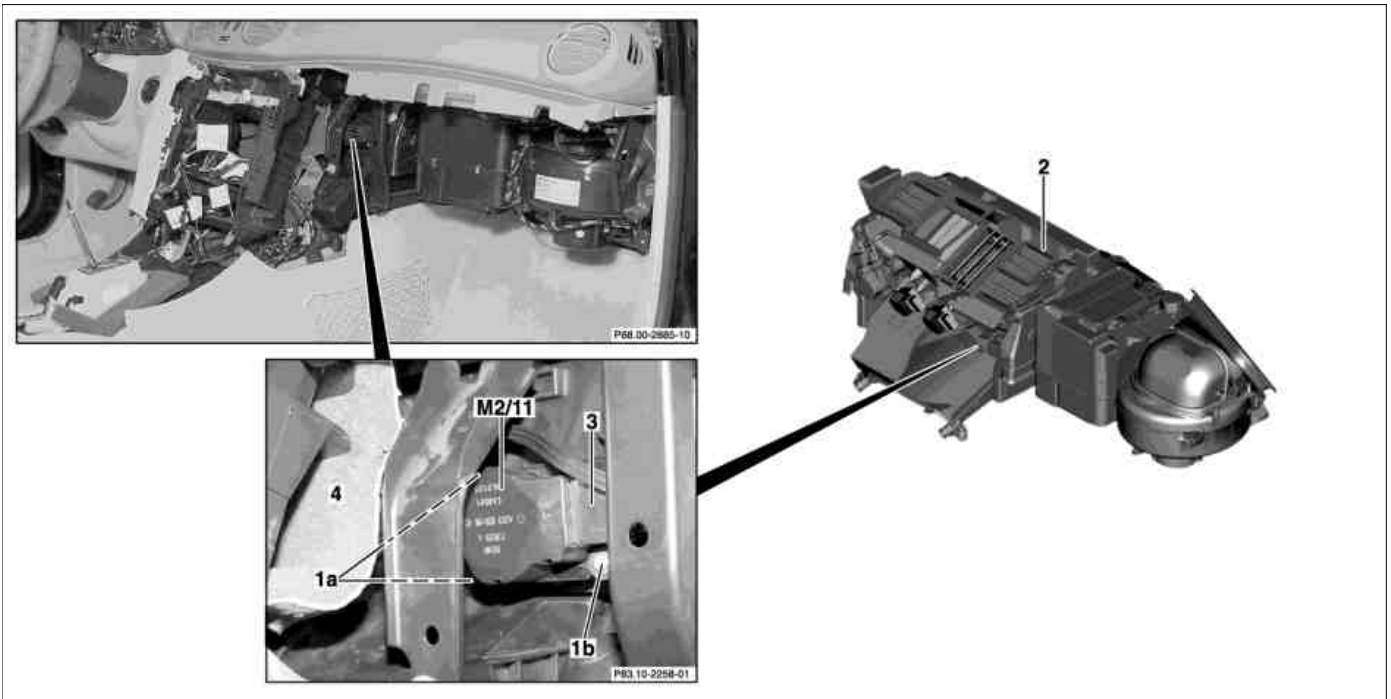
1a Bolts  
1b Screw

2 AC housing  
3 Electrical connector

4 Vapor barrier

M2/11 Right footwell flap positioning motor

2.1	Remove stowage compartment below radio	With MB Audio 10 CC radio with VK/RDS, with MB Audio 10 CD radio with VK/RDS, code 756	
3	Remove lower section of instrument panel on passenger side		AR68.10-P-1507Q
4	Remove cover below instrument panel on passenger side		
5	Remove center console air duct		
6	Push damping (4) to side		
7	Unscrew screws (1a, 1b)		
8	Detach right footwell flap actuator motor (M2/11)		
9	Separate electrical plug connection (3)		
10	Install in the reverse order		
11	Connect STAR DIAGNOSIS, normalize right footwell flap actuator motor (M2/11)	STAR DIAGNOSIS diagnosis system	*WH58.30-Z-1048-13A
