MODEL 209 as of 1.6.04

Shown on MB Audio 20 radio

P82.60-4728-11

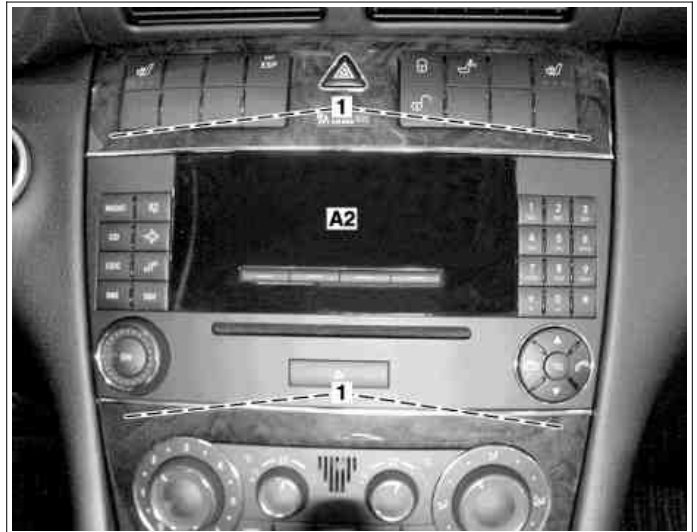
- 1 Bolts
A2 Radio

Remove/install		
1.1	Transfer basic data from radio (A2) to STAR DIAGNOSIS Connect STAR DIAGNOSIS and read out fault memory	When replacing radio (A2). i Installation: transfer temporarily stored basic data to the new radio (A2). STAR DIAGNOSIS diagnosis system	 AD00.00-P-2000-04A *WH58.30-Z-1048-13A
2	Remove upper control panel control unit.		AR54.21-P-1262Q
3	Remove control and operating unit		AR83.40-P-6350QA
4	Remove bolts (1)		
5	Withdraw radio (A2)		
6	Detach coupling from radio (A2)
