AZ82.60-P-0001-02Q Retrofit iPod wiring harness

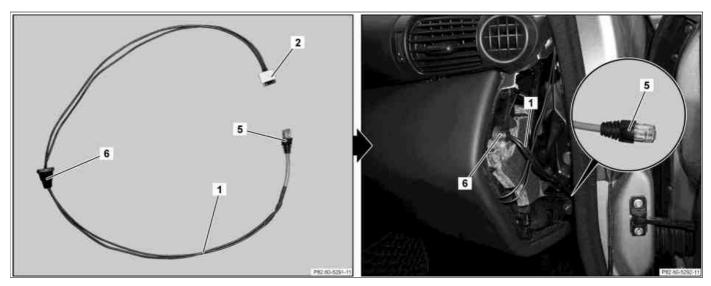
P82.60-5293-08

3 Guide interface connector (5) of the iPod wiring harness (1) from the inside out through the opening in the glove compartment and route in the front passenger footwell as shown in the figure (see magnification).

4 Install grommet (6) in opening in glove compartment, and route and secure iPod wiring harness (1) as shown in figure.

i If the diameter of the opening in the glove compartment is not large enough for fitting the grommet (6), enlarge the opening until the grommet (6) can be fitted tightly.

- 5 Install cover on side of glove compartment.
- Bensure that the iPod wiring harness is not pinched.
