Illustrated on model 209.3

P68.10-3905-06

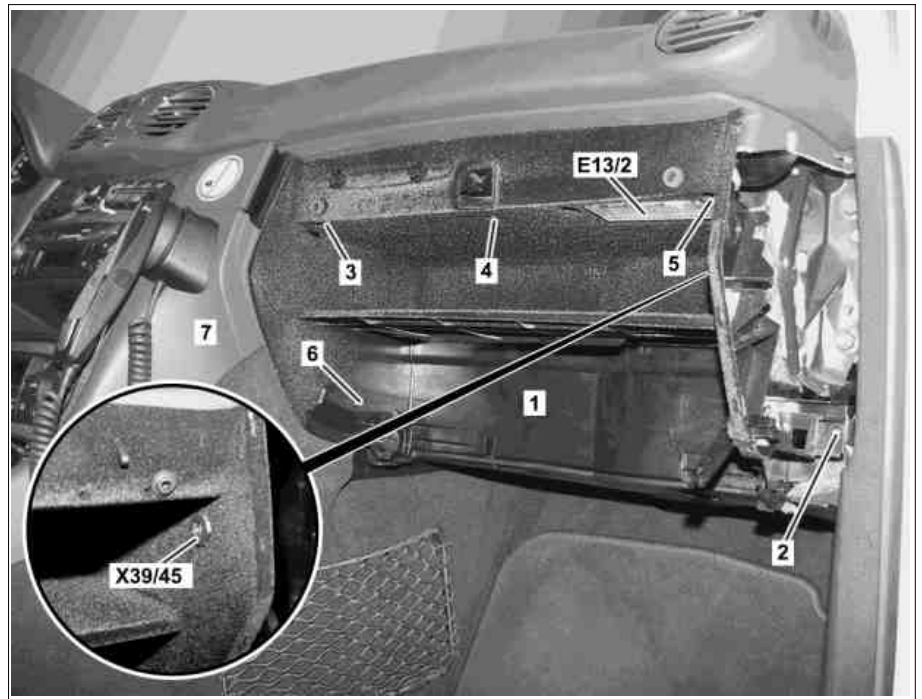
- 1 Glove compartment
 2 Screw
 3 Screw
 4 Screw
 5 Screw
 6 Notch
 7 Lower section of dashboard

E13/2 Glove compartment illumination with switch

X39/45 Walkman separation point

Remove/install		
1	Remove cover below right dashboard		AR68.10-P-1520P
2	Remove glove compartment lid		AR68.10-P-1200Q
3	Remove CD changer	On vehicles with code (819) CD changer.	AR82.64-P-7507P
4	Remove walkman separation point (X39/45)	On vehicles with code (523) Audio 20 with CD changer or with Code (525) MB Audio 50 APS radio or with Code (527) COMAND APS with single drive (with navigation) or with Code (529) HIGH Class Japan or with Code (530) COMAND APS USA (with navigation) or with Code (535) Audio 20 CD radio, USA.	AR68.10-P-1400-01CW
5	Unscrew bolt (2)		
6	Unscrew screws (3, 4, 5)		
7	Press in catch (6)		
8	Remove glove box (1) out of instrument panel lower section (7) at side

Installation: First install glove compartment (1) in guide rail	
9	Disconnect electrical connector from glove compartment illumination with switch (E13/2)		
10	Disconnect electrical connector for ATA glove compartment switch	Only on model 209.4 with code (551) Anti-theft alarm system (ATA).

11	Remove electrical connector from glove compartment CL solenoid.	Only on model 209.4.	
12	Remove glove compartment (1)		
13	Install in the reverse order
