P83.10-2357-09

Removal/installation	
		1 Remove cross member under instrument panel	AR68.10-P-1120QA
		2 Remove damping (2)	
		3 Remove bolts (1)	
		4 Detach left footwell flap actuator motor (M2/10)	
		5 Separate electrical connection (3)	
		6 Install in the reverse order	
		7 Connect STAR DIAGNOSIS, normalize left footwell flap actuator motor (M2/10), read out and erase fault memory	AD00.00-P-2000-04A
	AD	Connect STAR DIAGNOSIS and read out fault memory	*WH58.30-Z-1048-13A
		8 Perform function check	Diagnosis system STAR DIAGNOSIS

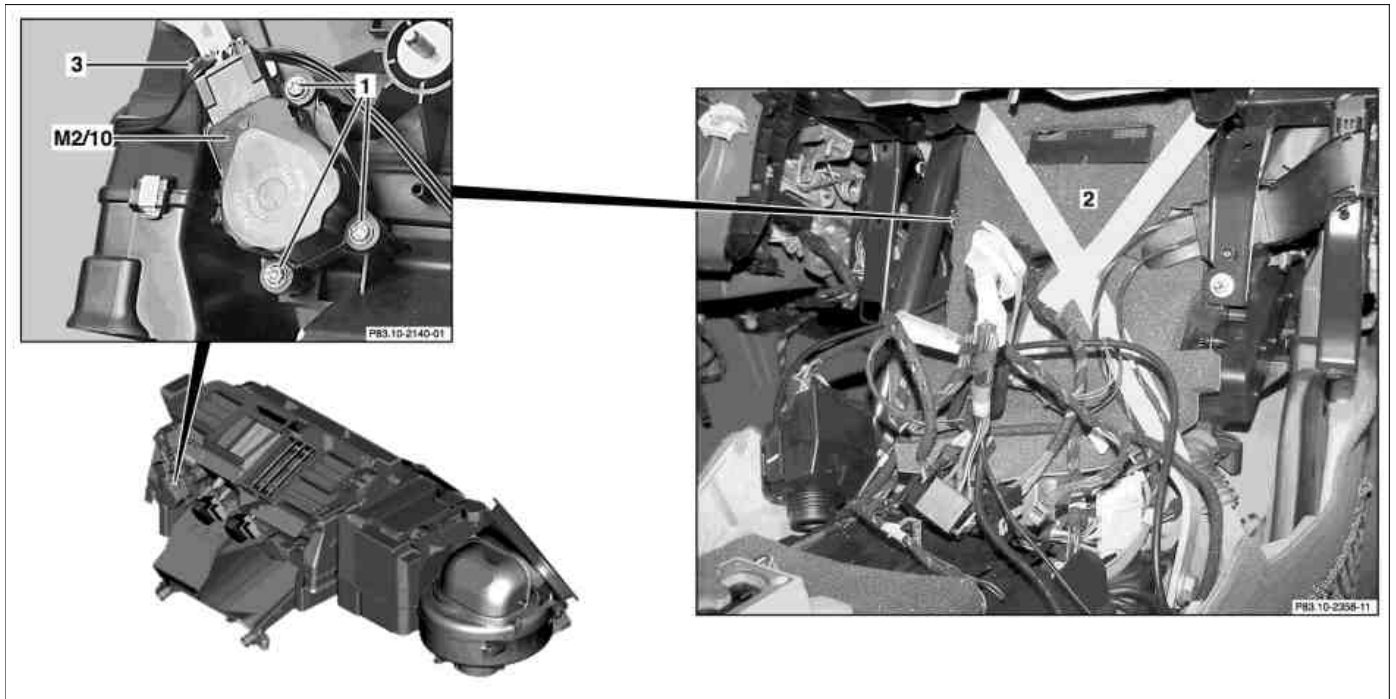
- 1 Bolts
- 2 Vapor barrier
- 3 Electrical connector
- M2/10 Left footwell flap positioning motor
