MODEL 209

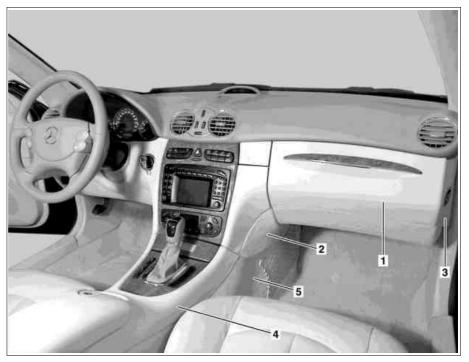
P68.10-3084-06

- Glove box
- Instrument panel lower section on passenger side 2
- Right instrument panel cover Center console 3
- 5 Footwell paneling

XX	Remove/install		
1	Remove cover below instrument panel		AR68.10-P-1520P
2	Open glove box compartment door		
3	Remove cover on right side of instrument panel (3)	i Do not break off front retaining tabs.	
			*110589035900
4	Press circlip of socket (6) toward inside		
5	Unclip socket (6) for glove compartment (1)		
6	Remove CD changer	With code 819 6-disk CD changer	AR82.64-P-7507P
7	Remove bolts (8)		
8	Remove center console cover (10)		AR68.20-P-2350Q
9	Remove center console (4)	Model 209 without code P98 Black Series	AR68.20-P-2000Q
		Model 209 with code P98 Black Series	AR68.20-P-2000QBS
10.1	Loosen COMAND operating, display and controller unit (A40/3)	up to 31.5.04 with code 352 COMAND operating and display system, with code 498 Japanese version	AR82.85-P-7472Q

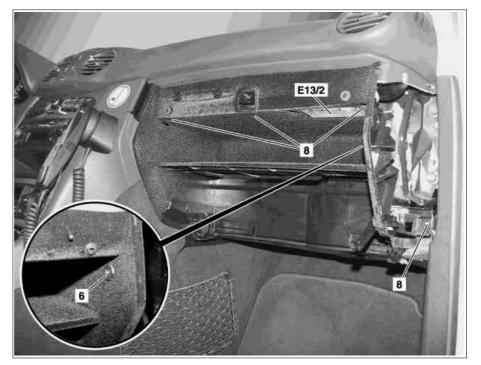
P68.10-3085-06

Socket 6 Bolts

E13/2 Glove box illumination with switch

10.2	Loosen radio	up to 31.5.04 with code 756 Radio MB Audio 10 CD with VK/RDS as of 1.6.04 up to 31.5.04 with code 353 Audio 30 APS as of 1.6.04 with code 525 Radio MB Audio 50 APS i Position radio so that bolts on instrument panel lower section on passenger side (2) are accessible. i Do not unplug connectors.	AR82.60-P-7502Q AR82.60-P-7502QA AR82.61-P-7412P AR82.61-P-7412QA
11	Remove bolts (9)		
12	Partially pull out instrument panel lower section on passenger side (2) with glove compartment (1)		
13	Detach coupling at glove compartment illumination with switch (E13/2)

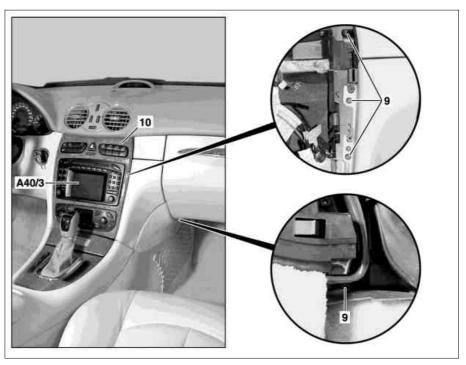
P68.10-3086-06

9 Bolts

10 Center console cover

A40/3 COMAND operating, display and controller unit

as of 1.6.04 with code 498 Japanese version, with code 527 COMAND APS (with navigation), with code 530 COMAND APS USA (with navigation) i Position COMAND operating, display and controller unit (A40/3) so that bolts on instrument panel lower section on passenger side are accessible.	AR82.85-P-7472QA
		i Do not unplug connectors.
