MODEL 209 with CODE (581b) Convenience automatic air conditioning

M2/5 Fresh and recirculated air flap actuator motor

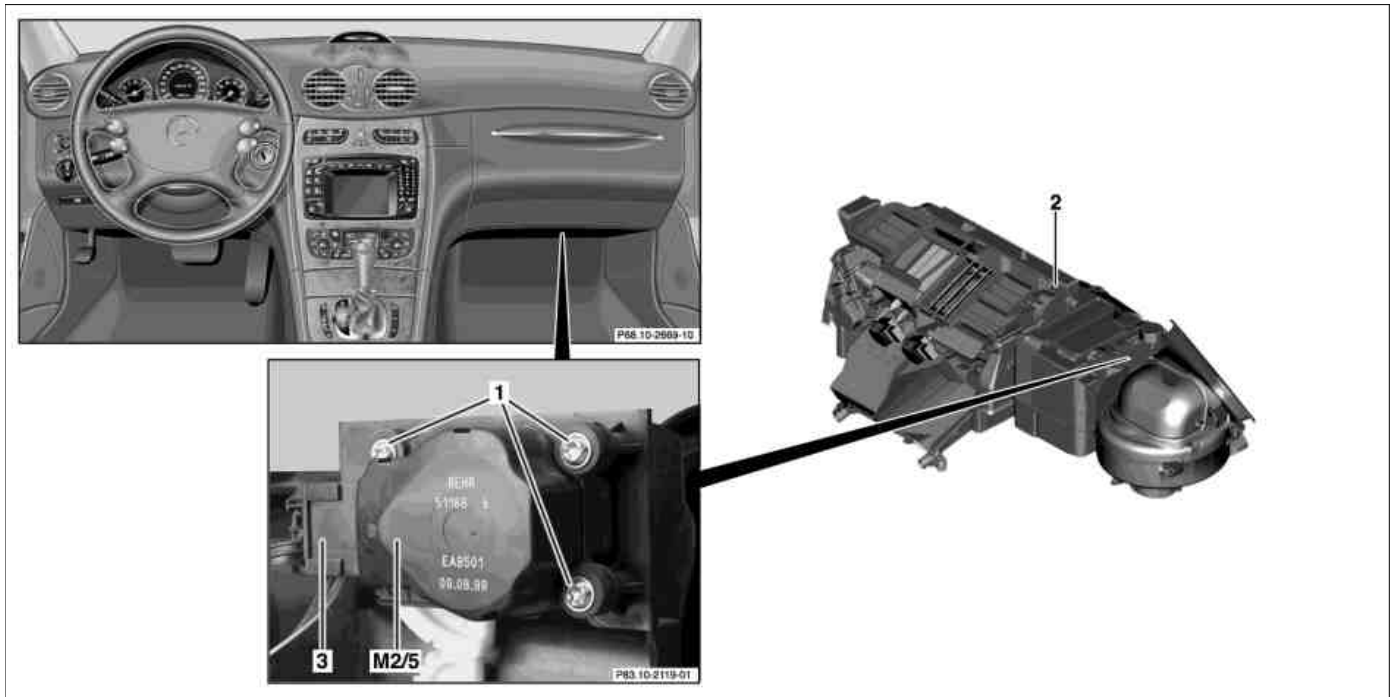
P83.10-2253-09

1 Bolts
2 AC housing

3 Electrical connector

Remove/Install		
1	Remove instrument panel		AR68.10-P-1000Q
2	Remove bolts (1)		
3	Remove fresh and recirculated air flap actuator motor (M2/5)		
4	Separate electrical connection (3)		
5	Install in the reverse order		
6	Connect STAR DIAGNOSIS, normalize fresh and recirculated air flap actuator motor (M2/5), read out fault memory and delete Connect STAR DIAGNOSIS and read out fault memory	Diagnosis system STAR DIAGNOSIS	AD00.00-P-2000-04A *WH58.30-Z-1048-13A
7	Perform function check
