P83.10-2266-09

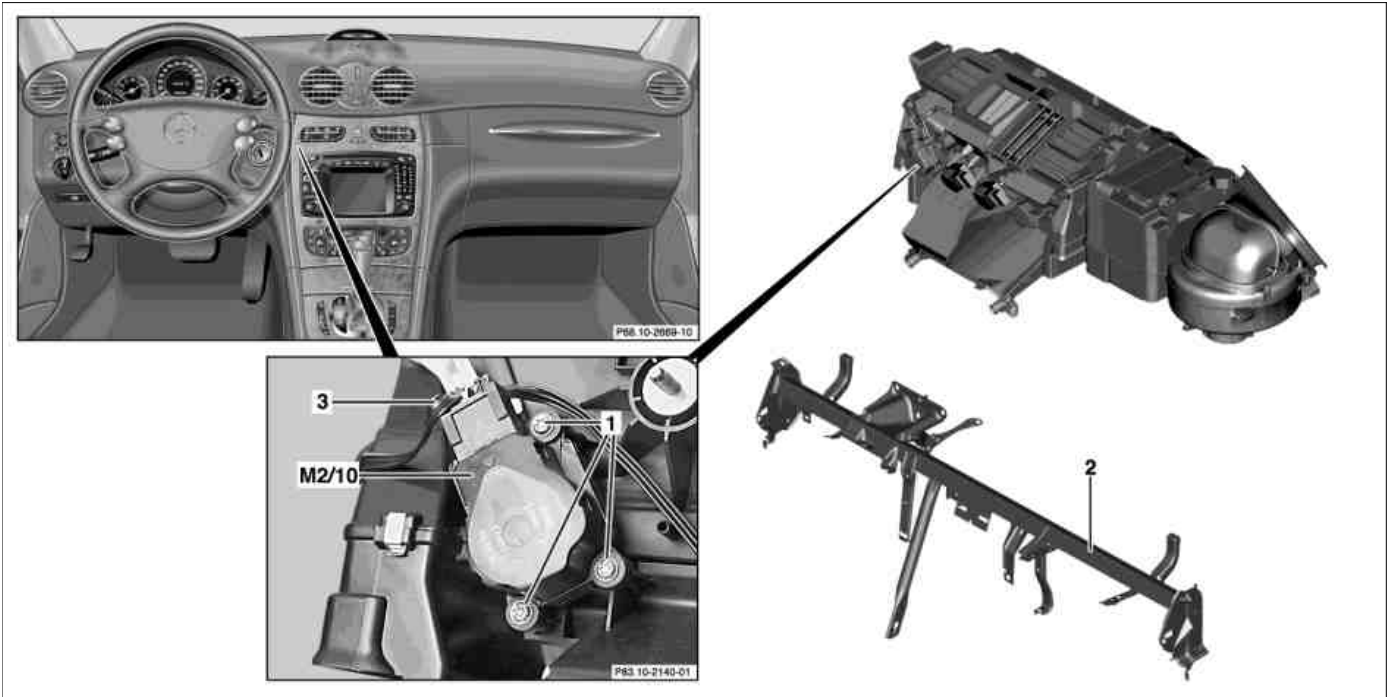
- 1 Bolts
- 2 Cross member below instrument panel
- 3 Electrical connector
- M2/10 Left footwell flap positioning motor

🔍	Remove/Install		
1	Remove cross member under instrument panel (2)		AR68.10-P-1120Q
2	Remove damping in the area of the left footwell flap actuator motor (M2/10)		
3	Remove bolts (1)		
4	Detach left footwell flap actuator motor (M2/10)		
5	Separate electrical connection (3)		
6	Install in the reverse order		
7	Connect STAR DIAGNOSIS, normalize left footwell flap actuator motor (M2/10), read out and erase fault memory Connect STAR DIAGNOSIS and read out fault memory	Diagnosis system STAR DIAGNOSIS	AD00.00-P-2000-04A *WH58.30-Z-1048-13A
8	Perform function check
